# Appropriate Assessment Screening and Natura Impact Statement

Rosses Point, Sewerage Scheme Co. Sligo

MERC Consultants Ltd, Loughaunbeg, Inverin, Co. Galway. www.mercenvronmental.ie

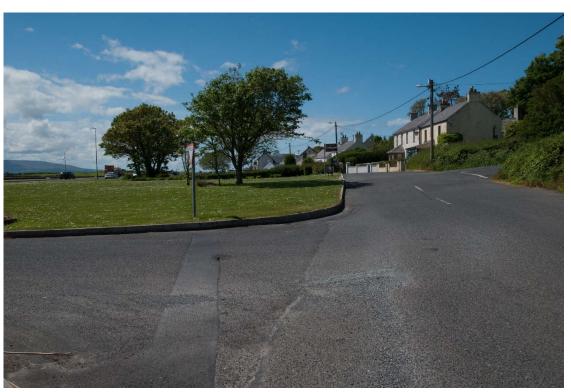
Figure 5.1. Upper R291 and amenity grassland adjacent to PS E3.

This section of the project follows a route through a grass verge (Amenity grassland (improved): GA2) which is managed by the local authority for landscaping (Figure 5.1). It is regularly mown and no species of conservation importance are present. The grass verge and minor sections of the road between the upper and lower (R291) roads will be opened to construct the new sewer. Trenching to carry out this work will include the digging of a trench approximately 0.5-3m deep and 1m wide in the road and grass verge. In the areas where the trench passes through the grass verge the excavated material will be used for backfilling and the surface sod will be reinstated. Any material not used for back filling will be removed from the site and disposed of at a licenced facility. This section of the proposed project is 20 meters from the relevant SAC and SPA boundary at its nearest point, and separated from it by the R291 coast road, a foot path and low sea wall along the seaward boundary. See figure Appendix.1.1.

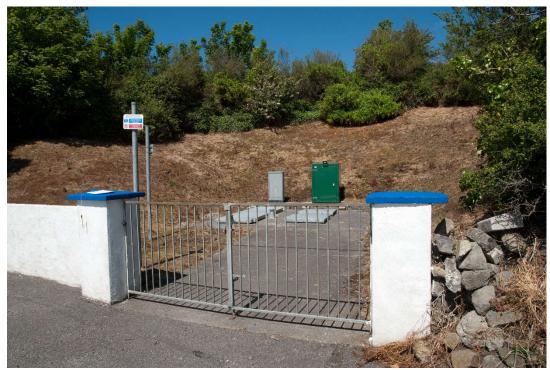
Figure 5.2. Existing PS E3 pumping station.

This existing pumping station will be the new Main Pumping Station for Rosses point and will pump flows forward for treatment to the Sligo Town Waste Water Treatment Plant (WwTP). The upgrade works include a full M&E upgrade, site works, new retaining wall and construction of a new **18m** long x **7m** wide x **6.5m** deep, **275m³** underground storm storage tank as shown in **Appendix A1.1**. Overflow from PSE3 will be screened through a 6 mm screen and passed through the storm storage tank where there will be retention of solids due to settlement. The existing overflow will be retained and used as the storm overflow from the new storm storage tank.

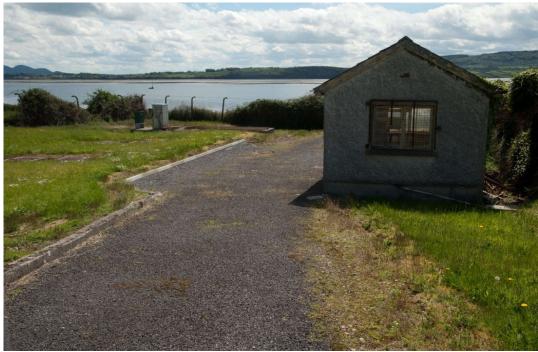
Figure 5.3. Existing waste water treatment plant.

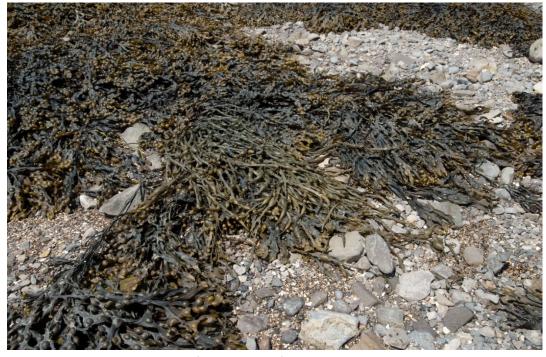
Figure 5.4. Sheltered intertidal reef to the south of the existing waste water treatment plant.

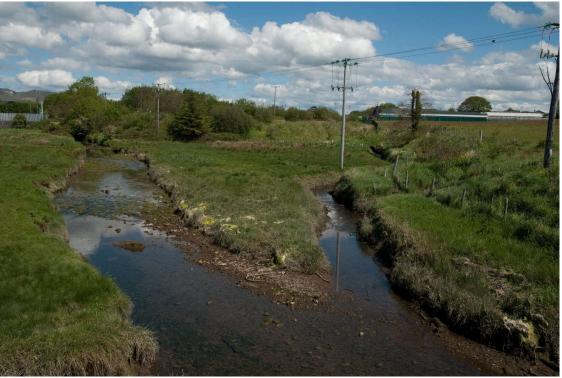
Figure 5.5. Willsborough Stream near R291 before entering Sligo Harbour.

The Willsborough Stream (FW2), a fourth order stream, drains the southern boundary of the field system entering Sligo Harbour under the R291 (figure 5.5). Two invasive alien species, Japanese knotweed (Fallopia japonica) and butterfly-bush (Buddleja davidii) were recorded in the area close to the road and along the stream margins on the east side of the road during the ecological site survey (figure 5.6). This area has not been treated by Sligo County Council under the Japanese knotweed control programme, although the area has signage indicating its presence. It appears some control (possibly by the land owner) may have been carried out on the north side of the road. However, living plants of Japanese knotweed remain and a number of individuals were also recorded on the west side of the road along

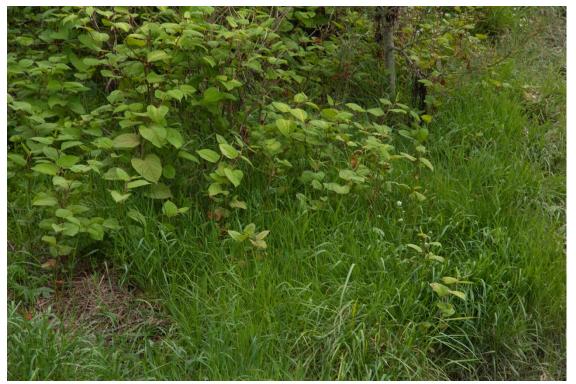
Figure 5.6. Japanese knotweed adjacent to the Willsborough Stream entering Sligo Harbour.

the banks of the Willsborough Stream where it entered Sligo harbour within the confines of Cummeen Strand/Drumcliff Bay (Sligo Bay) SAC and Cummeen Strand SPA (See figure 5.6).

The section of the proposed sewer that passes through this field system follows a route along a section of higher dry ground of improved agricultural grassland and separated from the wet grassland by a hedgerow. At its nearest point it is just over 200 meters distant from any recorded individuals of Japanese knotweed. The Willsborough Stream is 116 meters distant from the proposed works at its nearest point.

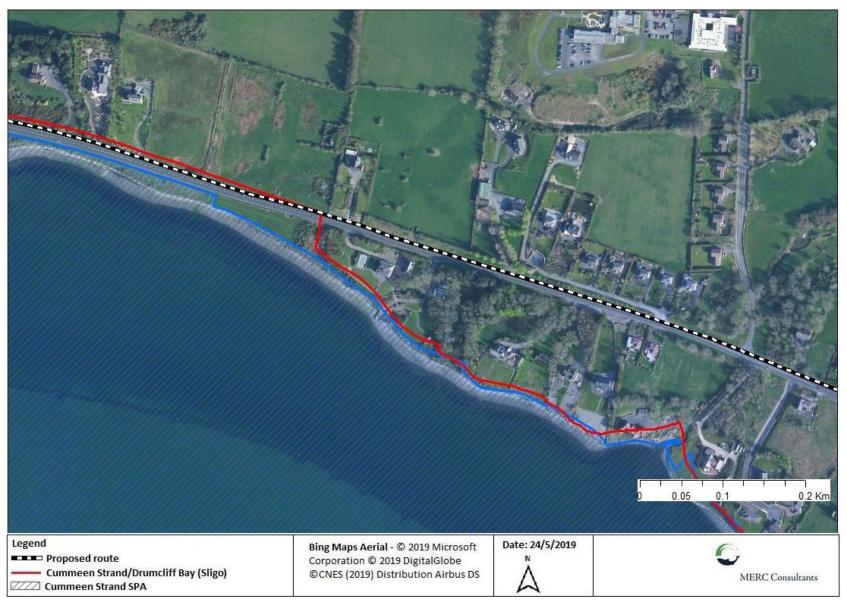
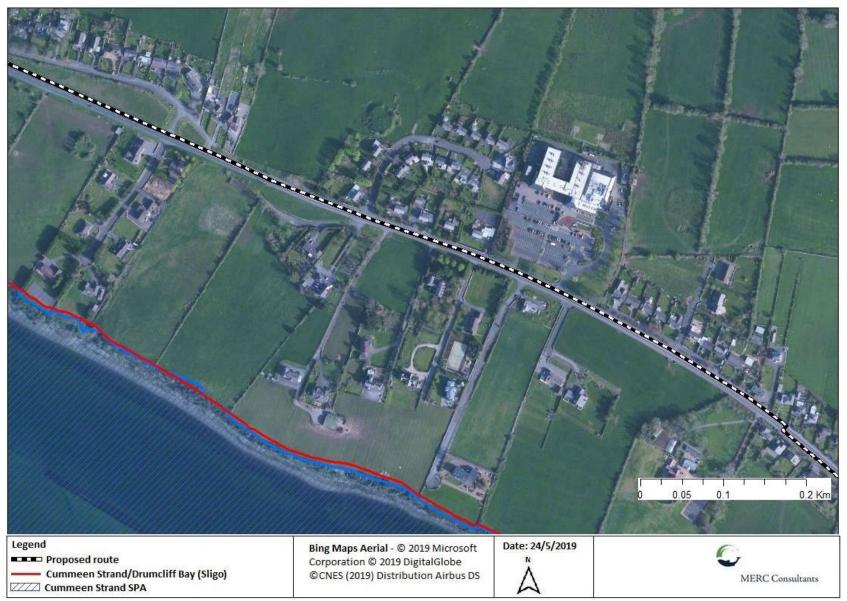
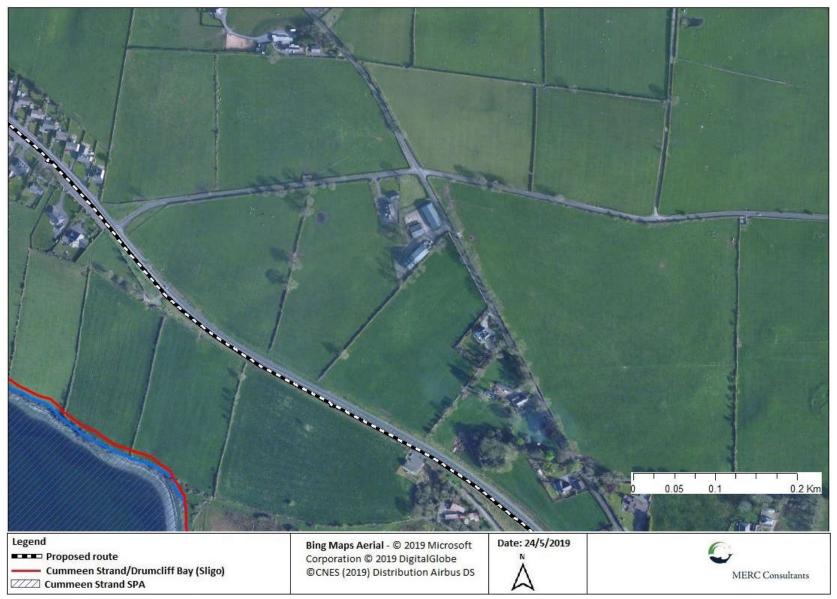
**A. 1.3** Component 6.

**A. 1.4** Component 6 Continued.

**A. 1.5** Component 6 Continued.

Component No. 6 involves the construction of a new **3.85km, 180mm** diameter rising main from the Main Pumping Station to a manhole at the head of the proposed gravity sewer opposite the Radisson Hotel. The rising main will be laid approximately **1.2m** below the existing ground level and will be constructed in the road/verge. Excavations and backfilling at this location will be the same as described for component 1 above. See **Appendix A1.3 to A1.6** for works location.

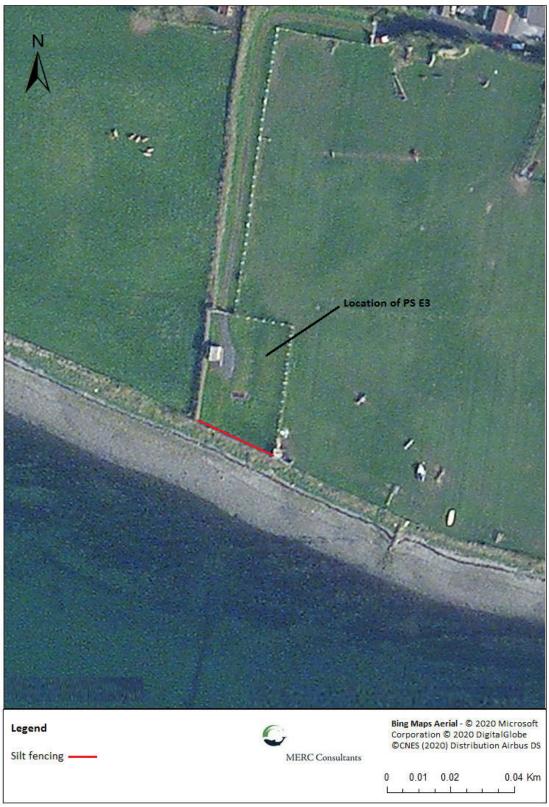
A.2 Location of silt fence at PS E3.

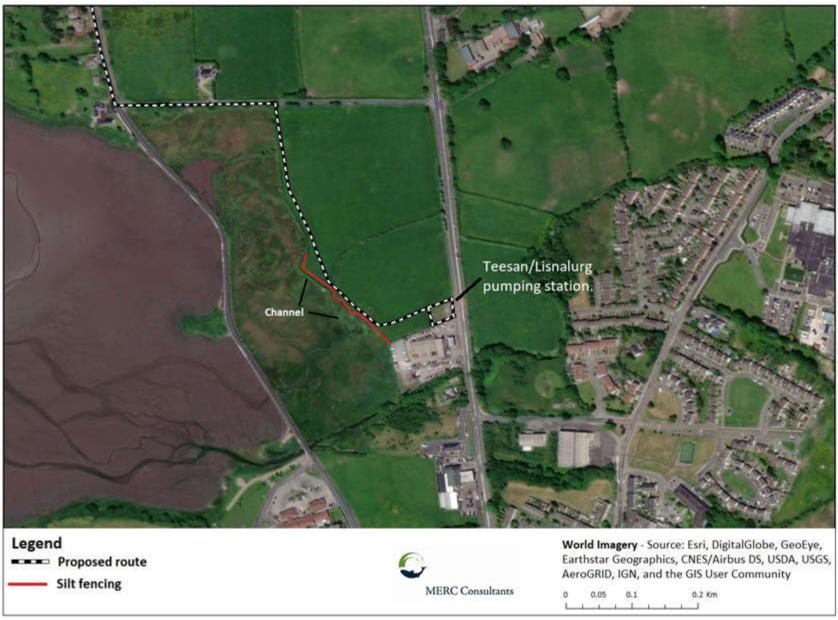
**A.3** Location of silt fence at component 7.
