THE GREEN FORT CONSERVATION PLAN

Draft 7.0 Document for Public Consultation
September 2017

Prepared by Jason Bolton, Pat Dargan and Niamh Roche for Sligo County Council

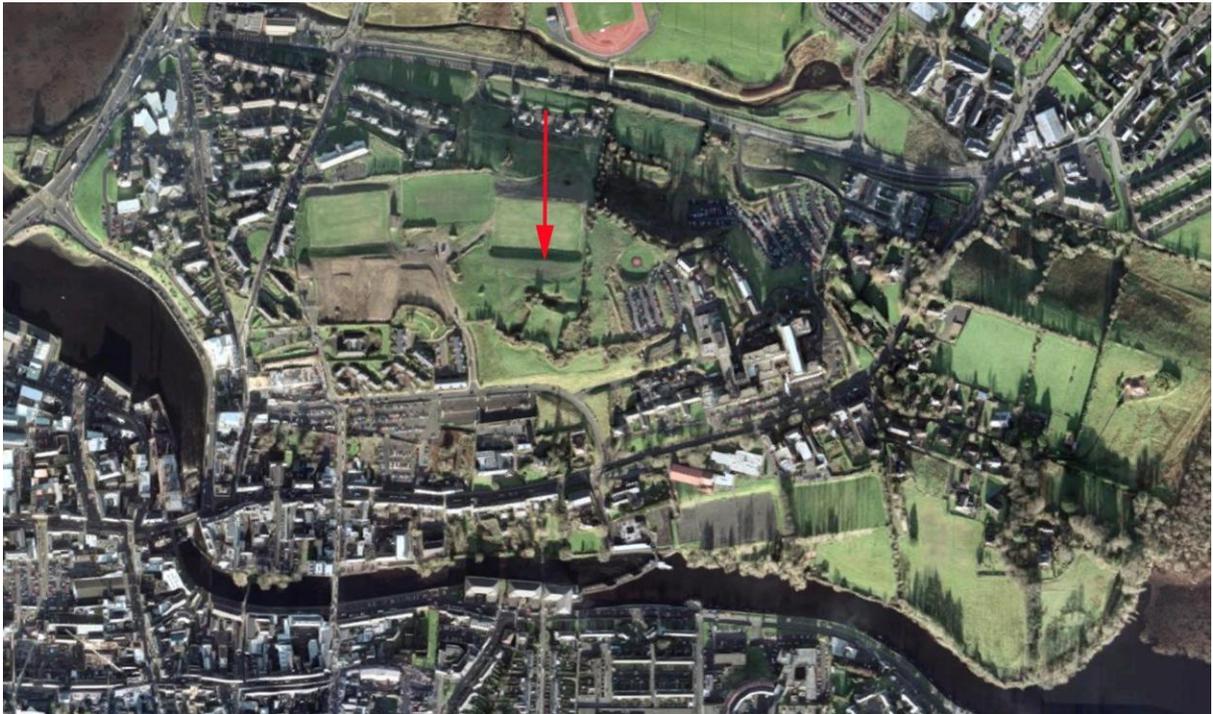
Fig.8: The Green Fort lies in semi-natural grassland at the top of Fort Hill, overlooking Sligo Town and the Garvogue River, with Sligo University Hospital to the east, and with playing fields to the north and north-west. Source: Google Maps.

The monument lies on semi-natural grassland with sports grounds and Sligo Northside Community Partnership Centre to the north, a hospital to the east, sub-urban housing to the west, and overlooks Sligo town and The Model to the south. The site has 360° views of Sligo town and the surrounding landscape. The adjacent sports grounds form an important local amenity and are managed by the Park's Department, Sligo County Council. There is a single formal vehicular and pedestrian access from Connaughton Road through the housing estate of City View. A number of informal pedestrian access routes are also present.

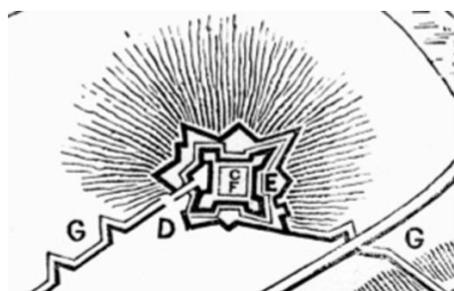
- C. The Green Fort, ‘The Earth Fort’
- D. Main entrance to the Fort
- E. Sally port to reinforce outer defences
- F. “ A Well, which is continually full of water”

Fig.11: Henry Luttrell's 1689 plan of the town and forts of Sligo, as re-drawn by Wood-Martin, 1882-92, ii, p.134 depicts the fort with outer entrenchments with their own earthen bastions, and a fortified 'sally port' to allow troops in the Green Fort to reinforce troops in the outer defences.

The Green Fort was depicted on a map in 1698 (Fig.12) which labelled the key parts. These included a well 'continually full of water', the main entrance at the south end of the west side of the fort, and a 'sally port' (a type of fortified doorway) in the east side which would allow troops from the fort to reinforce the outer defences. Today, the outer defences have been lost and only the Green Fort stands above ground as a visible testament to the seventeenth-century fortifications of Sligo town.

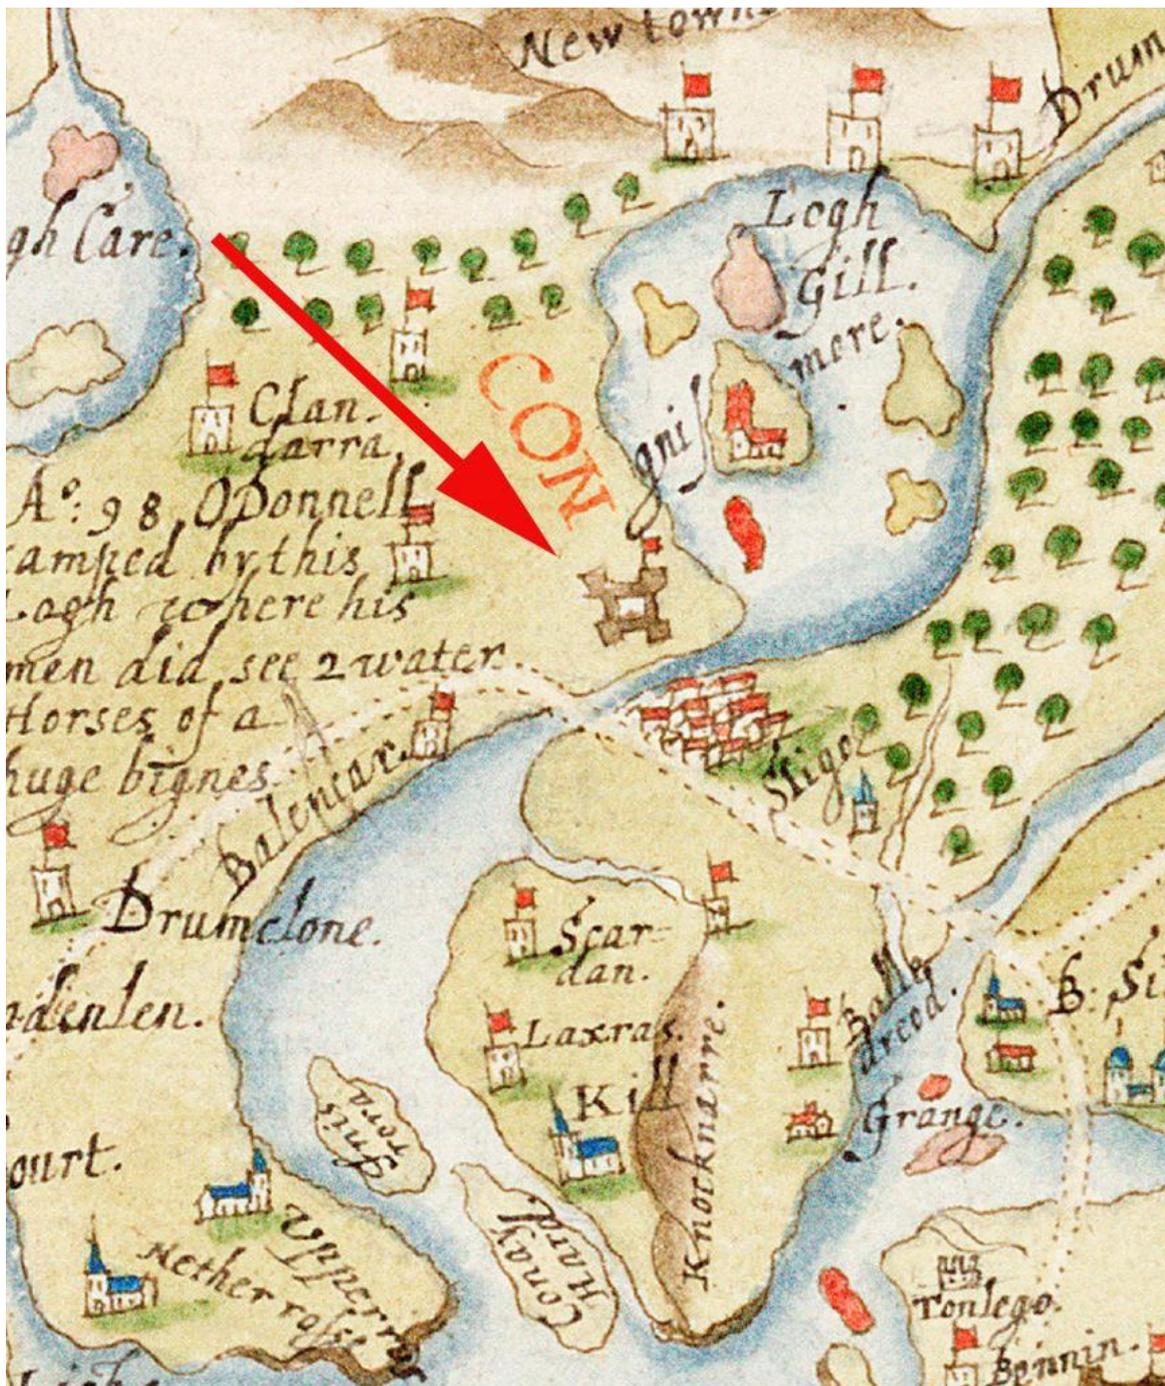
Fig.13: Captain John Baxter's map of north-west Ireland c.1600 depicting the presence of a bastioned fort on the north bank of the Garvoe River; presumably at the Green fort⁸. Source: National Maritime Museum, Greenwich.

A fort with spear-shaped bastions on the north side of the Garvoge River is first shown on Baxter's map c.1600 (Fig.13), and this may be the first depiction of the Green Fort. The fort is shown again on the Barony of Carbury and the parish of Calrie (Calry) maps during the Down Survey c.1655-8. The southern bastions are shown on Thomas Philips 'Prospect of Slego' c.1685 which show the fort abandoned and without any buildings within the earthen fortification. The fort and the town of Sligo appear to have undergone extensive re-fortification during the Williamite Wars c.1689-91 which included a defensive system of bastioned earthen defences encircling both the Green Fort and Sligo town. These were depicted on Luttrells 1689 defensive plan of Sligo. The Green Fort appears to have been abandoned relatively soon after the Williamite Wars and is not marked on Taylor and Skinners 1777 map of Sligo or William Larkin's 1810 map. The Green Fort is shown on the 1837 Ordnance Survey Fair Plan of the Parish of St. John's (Fig.22) and on all later Ordnance Survey maps (Fig.24) where it is shown as an isolated but well-defined rectilinear fortification with spear-shaped bastions.

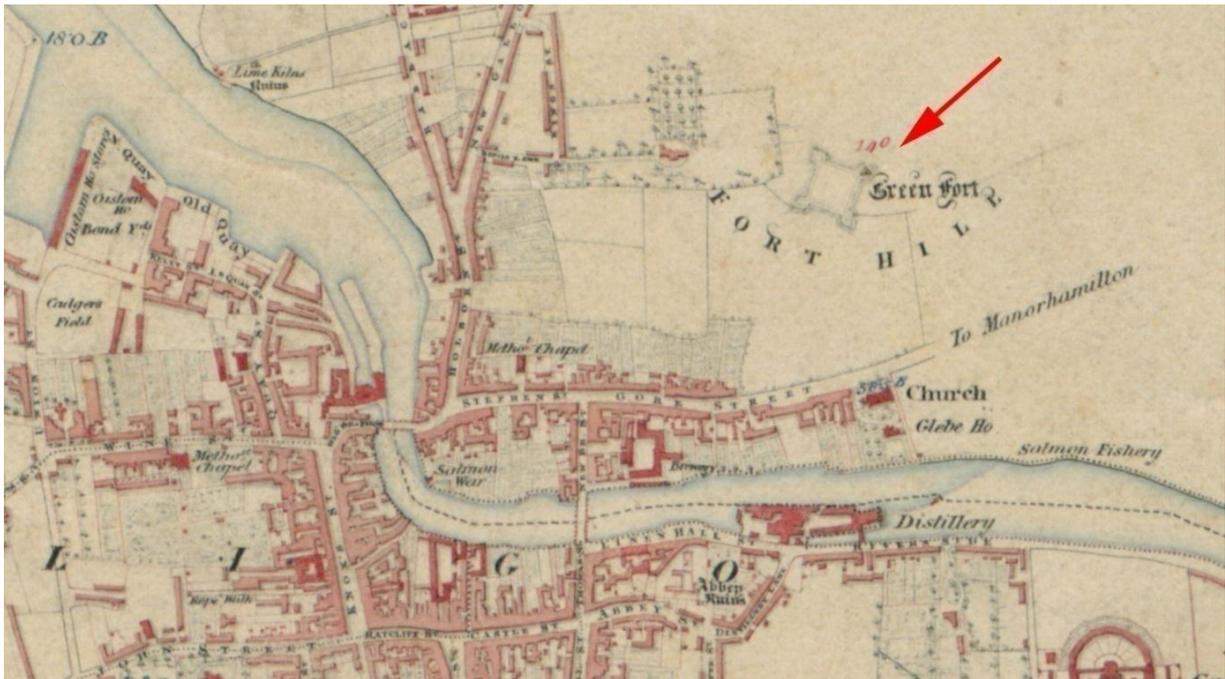
Fig.20: The Green Fort as depicted on the 1837 Ordnance Survey Fair Plan parish of St. Johns held by the National Archives of Ireland. Source: National Archives of Ireland.

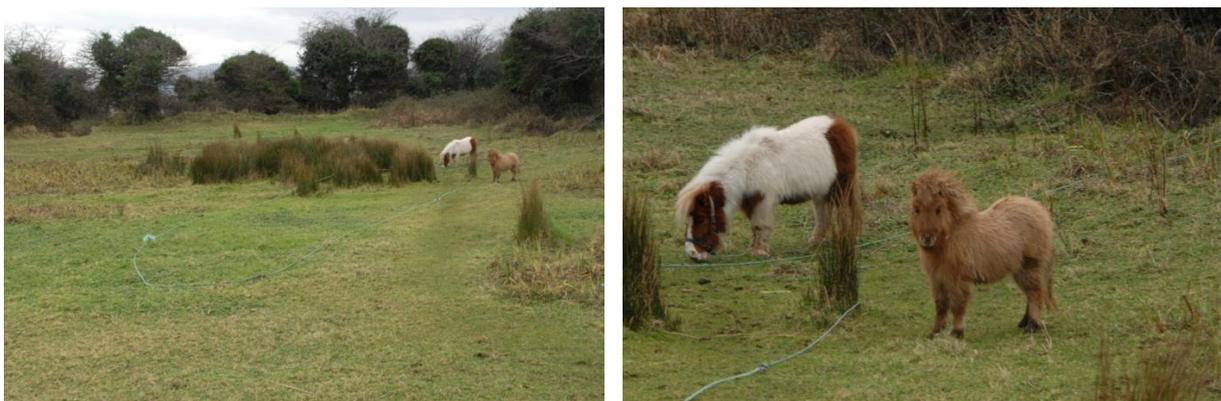
Fig.25: Small ponies grazing the interior of the fort (January 2017).

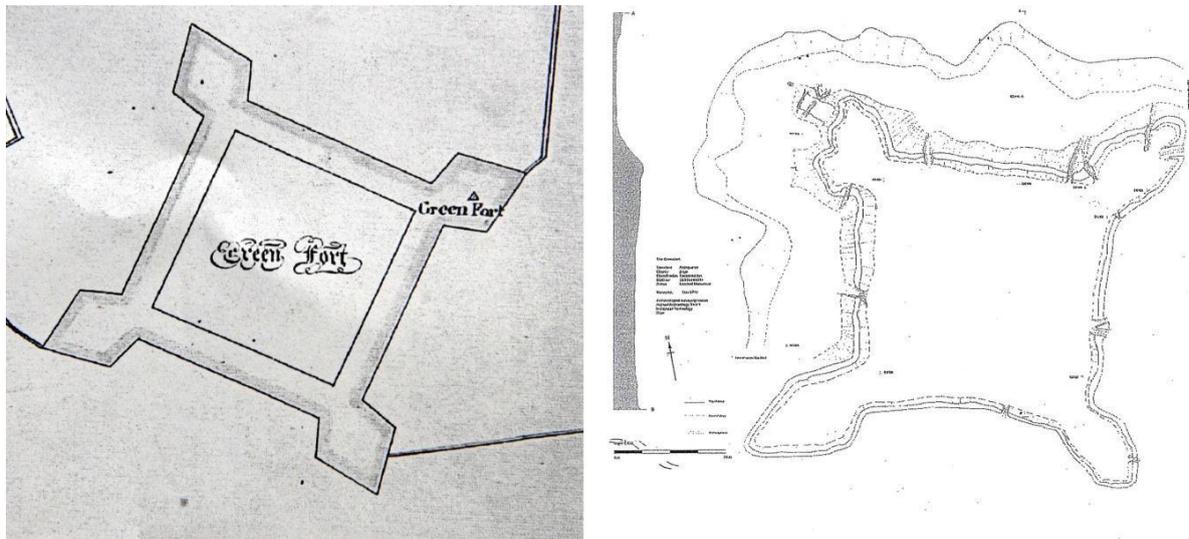
4.3.1 Erosion and Attrition: The monument is physically vulnerable from weathering and erosion of its earthen defences. All earthen banks and the three visible bastions show significant erosion and none can be said to retain an original 'face' of the fortification. The south-western bastion appears in the best condition in the most recent survey of the Green Fort by IT Sligo. However, the Monument Condition Report by Jason Bolton (2017) undertaken to inform the conservation plan (see appendix 1) noted that this bastion is entirely overgrown and the external slopes of the bastion are invisible from close inspection. It would be necessary to remove the existing vegetation to determine its actual condition. The earthen defences of the fort are covered with grass, trees and hedgerows. However, excessive removal of the existing vegetation cover would expose the earthen defences to erosion and weathering. Modern geotechnical solutions are available to preserve exposed soil slopes from erosion, however, these tend to be unsightly and would detract from the character and appearance of the monument.

Fig.26: Comparison between the Ordnance Survey map of the Green Fort in 1837 (see Fig.22) (left) and a drawing prepared by Sam Moore, IT Sligo in June 2016 (right) indicating loss to the bastions

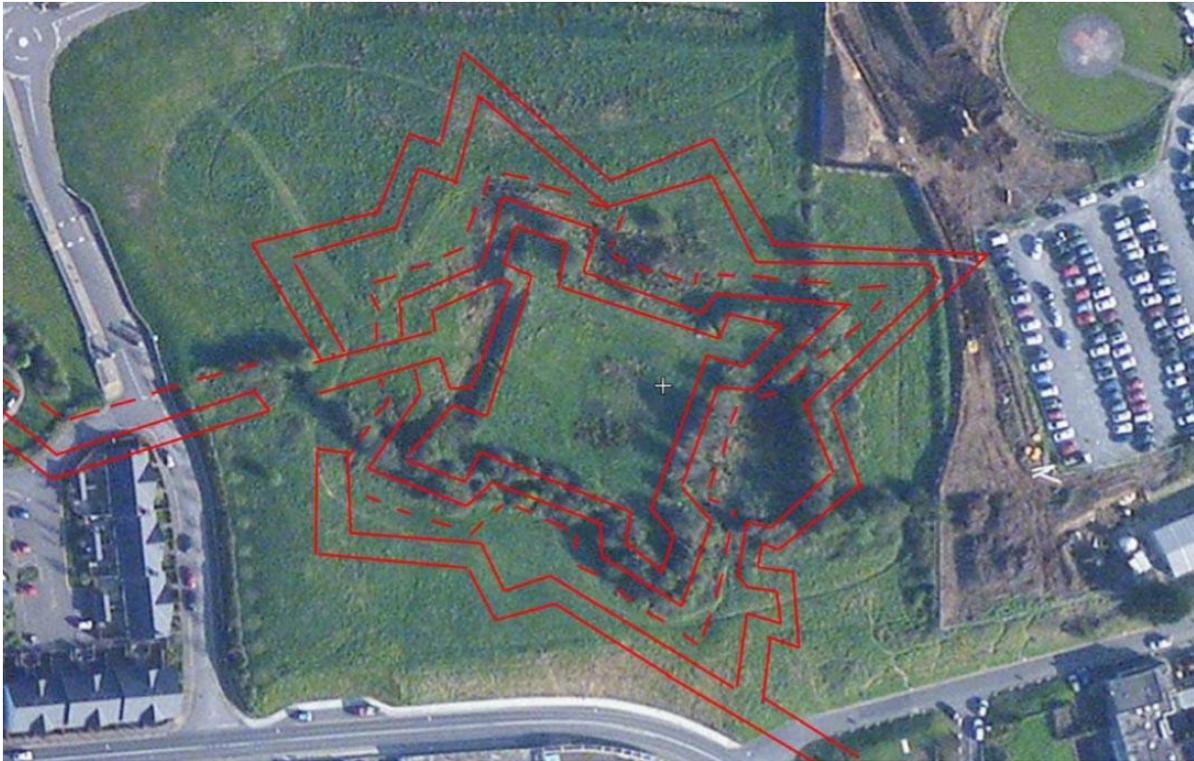
Fig.27: Overlay of Luttrell's plan of the Green Fort and adjacent late seventeenth-century earthwork town defences prepared by Sam Moore, IT Sligo. No trace of these extensive earthen fortifications are visible at ground level. However, nearby archaeological excavations have confirmed that stretches of these defences survive below ground level.

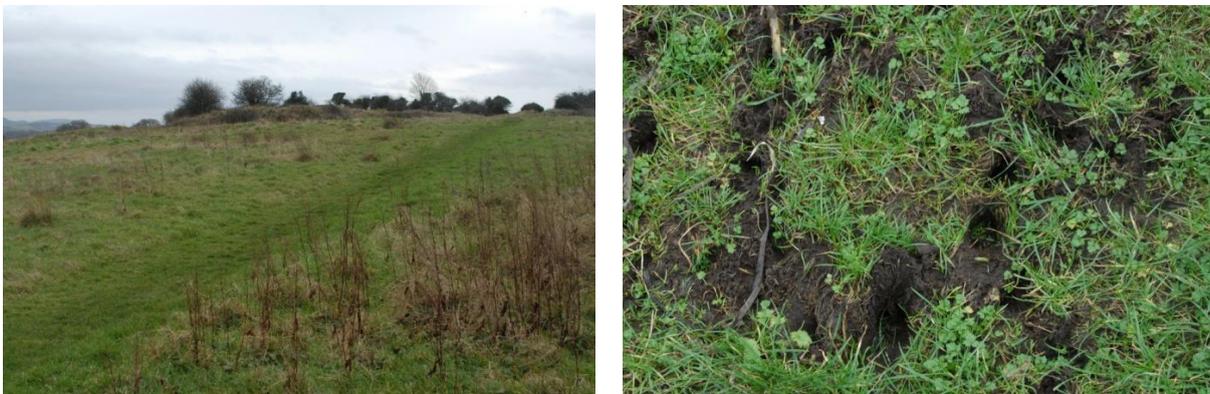
Fig.28: The main grassed entrance path west of the fort shows animal erosion and damage from foot traffic in wet conditions within the defensive ditch.

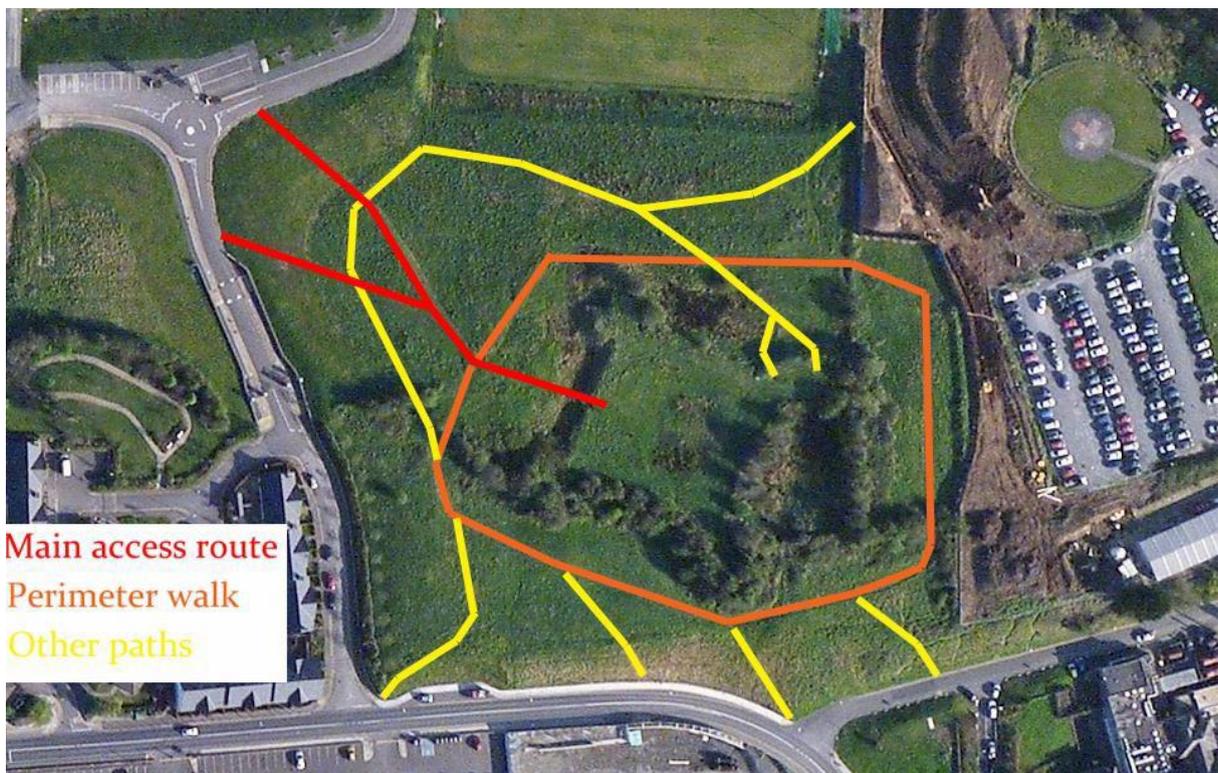
Fig.29: Walking routes around the Green Fort.

At present visitor numbers to the site appear to be quite low. However, there is no management of visitors, no defined walking routes and no signage informing them of the significance of the site and how vulnerable it is. This means that ground nesting birds are very vulnerable and that all areas of the site, including potentially unsafe steep embankments, are equally accessible. Any proposed increase to visitor numbers also requires clear vision and management to minimise disturbance of key species and habitats – especially given the fact that the site is quite small in area. There are significant views of the surrounding landscape from the Green Fort. Any increase to visitor numbers has the potential to lead to physical damage through erosion from foot traffic to the monument.

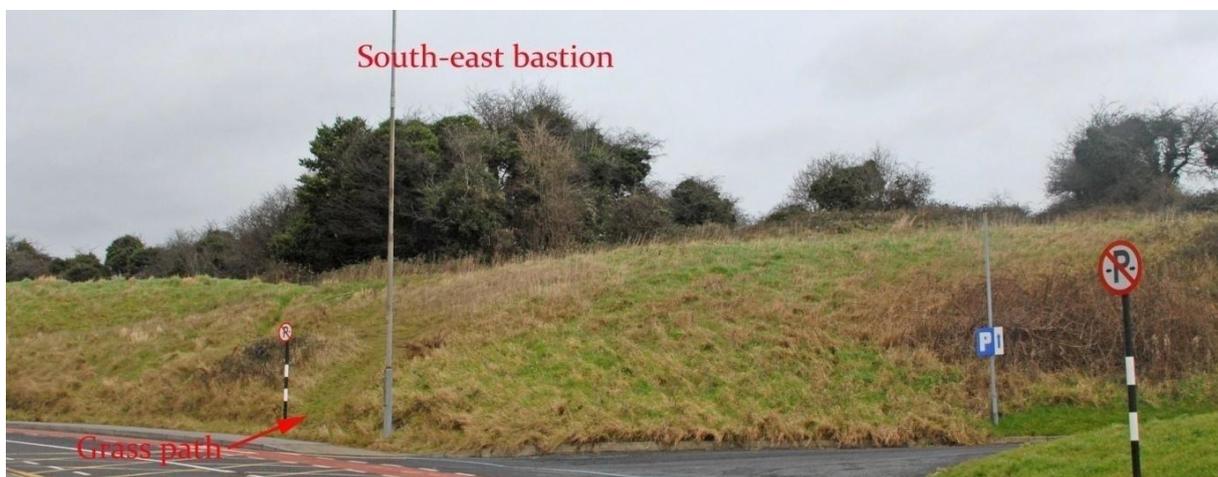
Fig.30: Informal grass path leading to the south-east bastion.

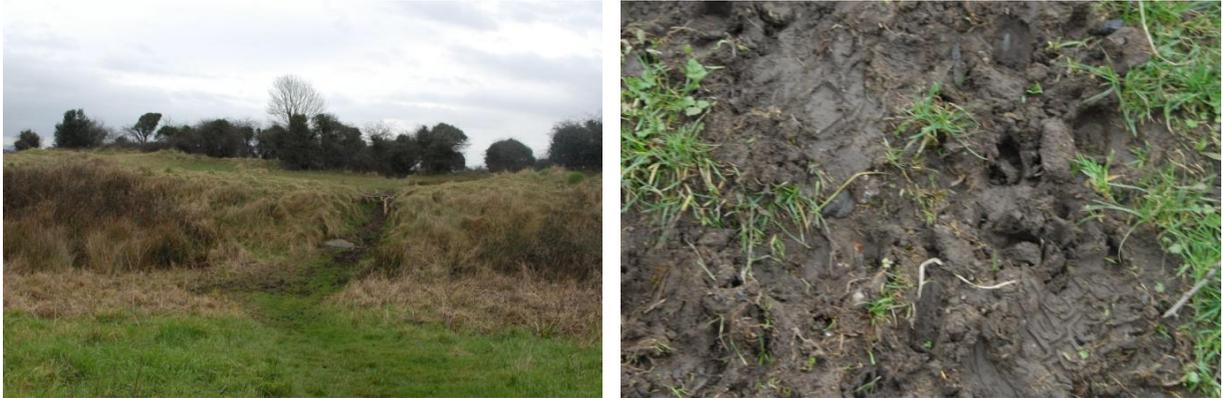
Fig.33: The main access onto the fort shows minor damage from human and animal traffic.

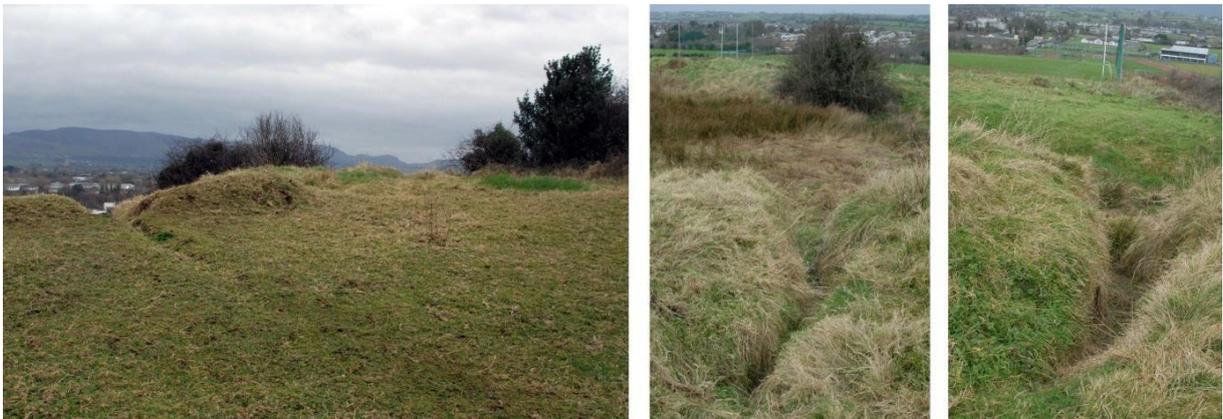
Fig.34: Access routes on the north bank of the fort forming relatively deep cuts into the earthen banks.

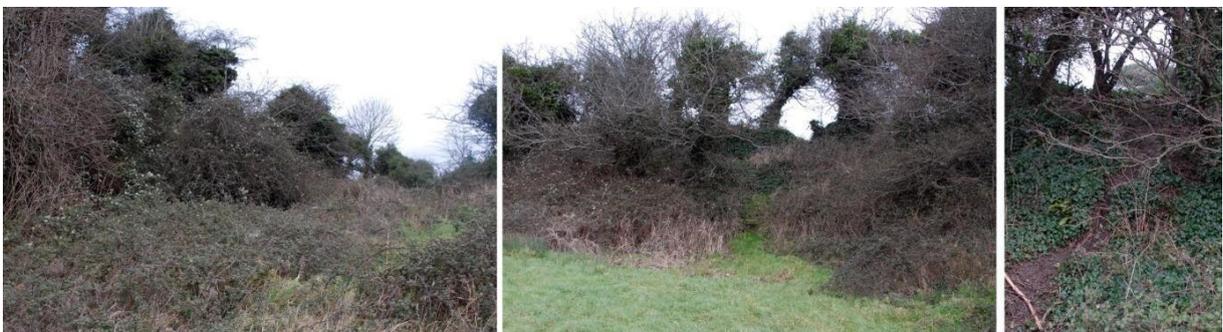
Fig.37: The east side of the fort is largely inaccessible (left). The south bank and bastions are largely overgrown and former

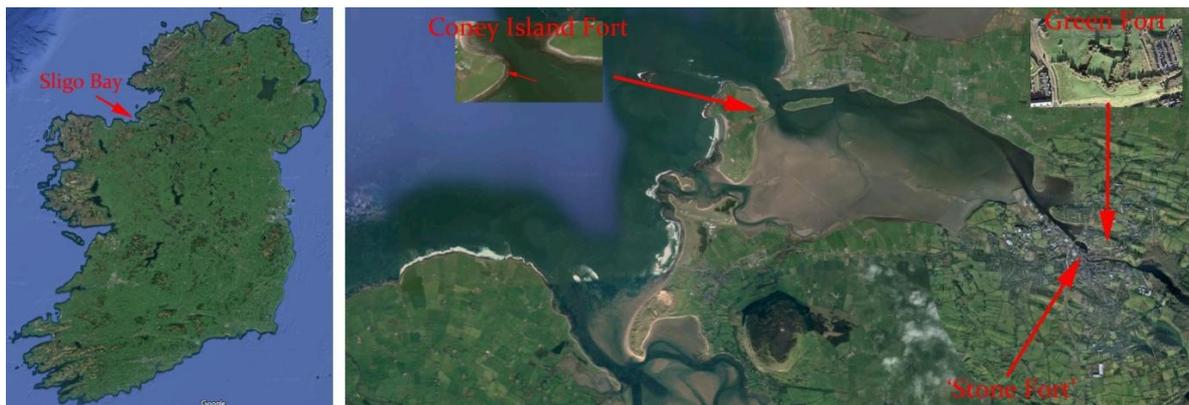
Above: The Green Fort is located on a hill overlooking Sligo town, and is located on the exposed west coast of Ireland.

The Green Fort is located on the summit of Fort hill in the townland of Rathquarter (Position 569546 836292) overlooking Sligo Town and is exposed to weather on all sides. Sligo has a west coast climate which is mild, with no dry season, warm summers and heavy precipitation occurring during mild winters. Annual mean temperature is 9.4°C with average monthly temperatures varying by 10.5°C. The average summer high temperature is 18°C, while in winter temperatures range from 8°C during the day falling to 1.3°C overnight. Total annual precipitation averages 1131mm.

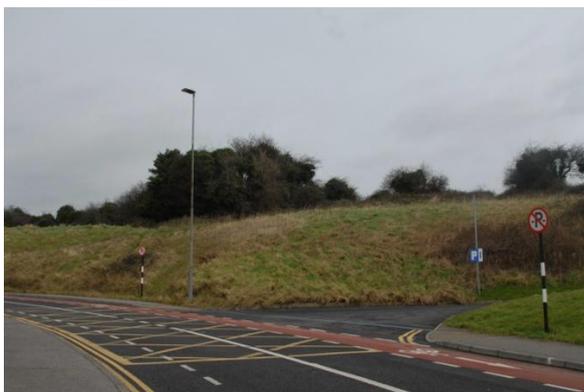
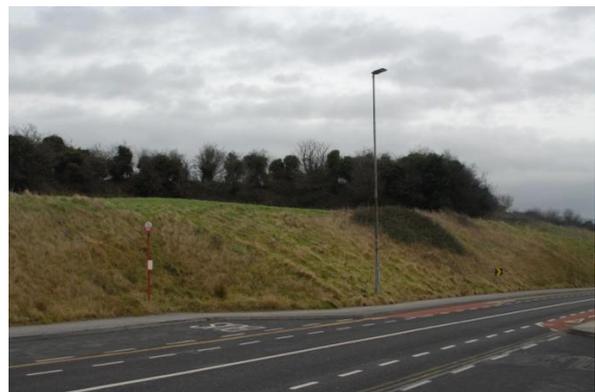
Above: The Green Fort is delineated by hedgerows, and it is not clear from Connaughton Road that the site is an archaeological monument.

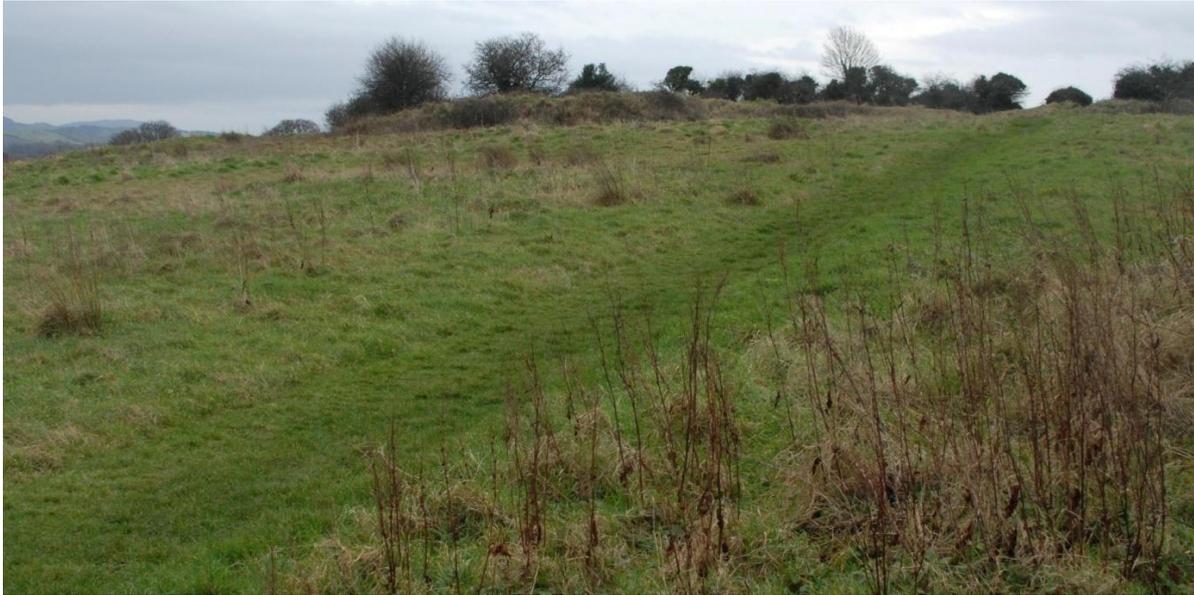
Above: The grassy path towards the fort from the O'Boyle Park car park is visible, however, it is not immediately clear that the raised bank and hedgerows beyond are part of an earthwork fortification.

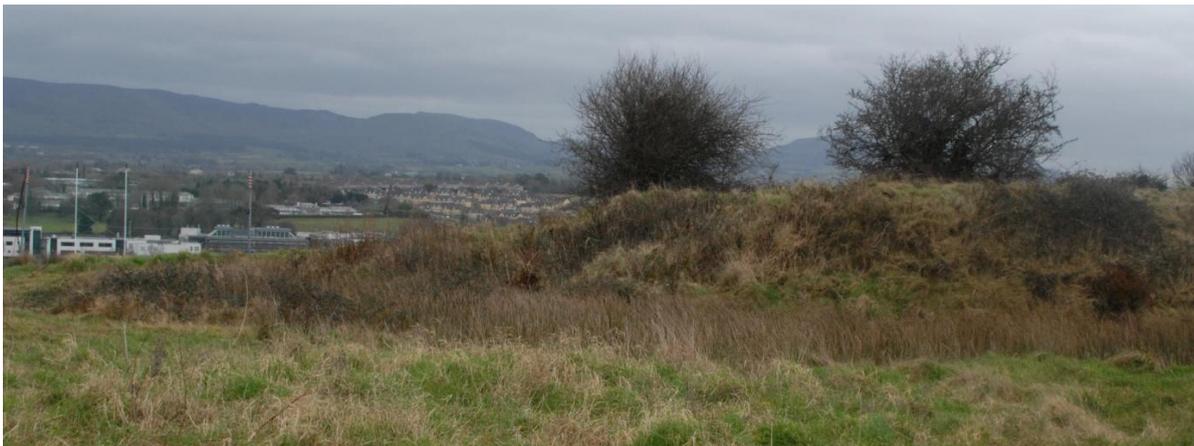
Above: On closer viewing, the bastions become clearer as an earthwork feature. However, it would be difficult for the general public to appreciate the archaeological significance of the fort without interpretation in the form of a guided tour or additional signage.

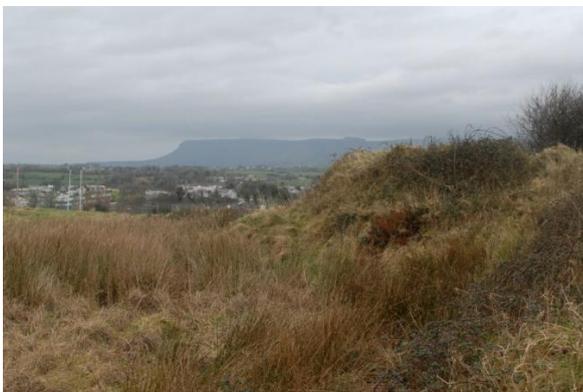
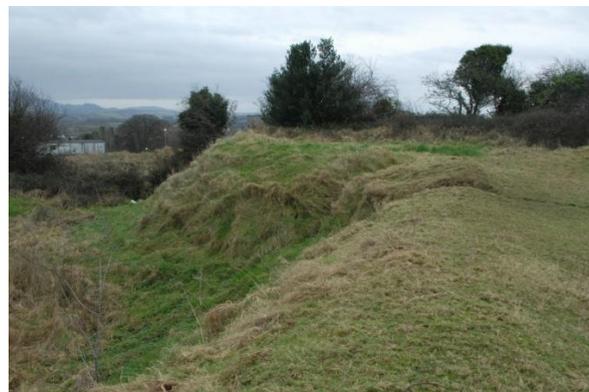
Above: The bastions are the most easily recognisable feature of the Green Fort from ground level, and are best viewed from within and immediately adjacent to the fort.

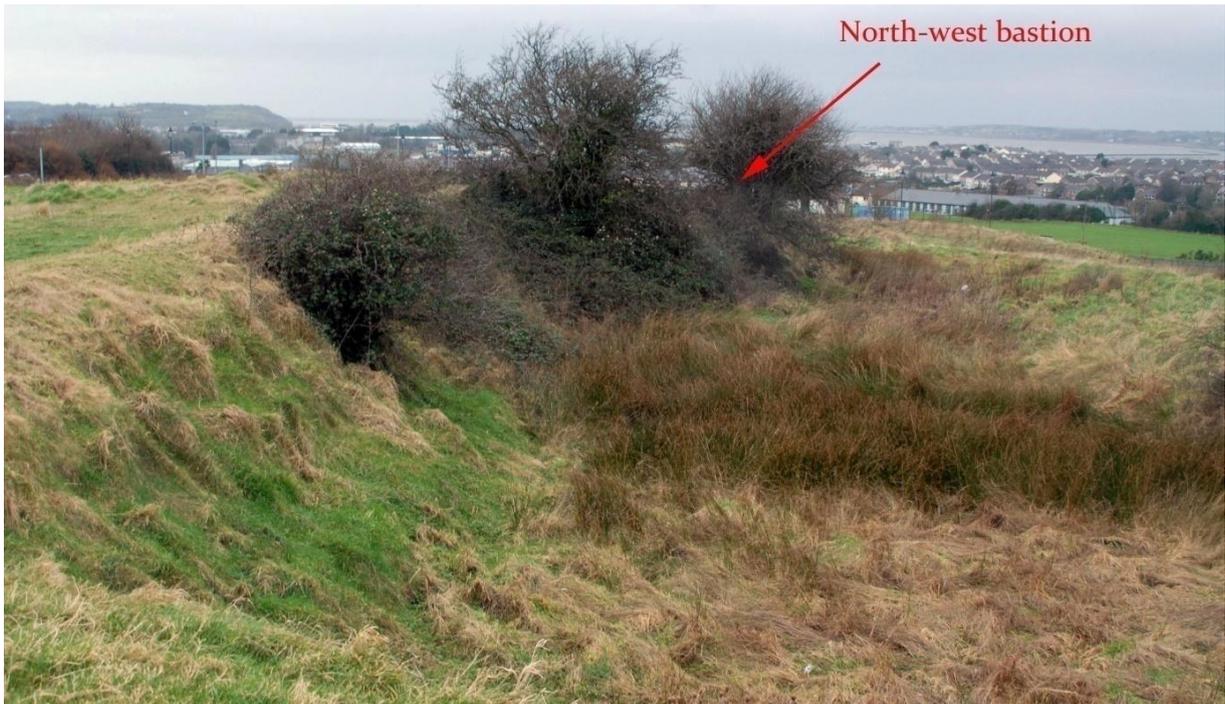
Above: View along the north bank showing the north-west bastion with Sligo Bay in the background. The bank and wide ditch are visible but may not be recognisable as part of an archaeological monument to a casual visitor.

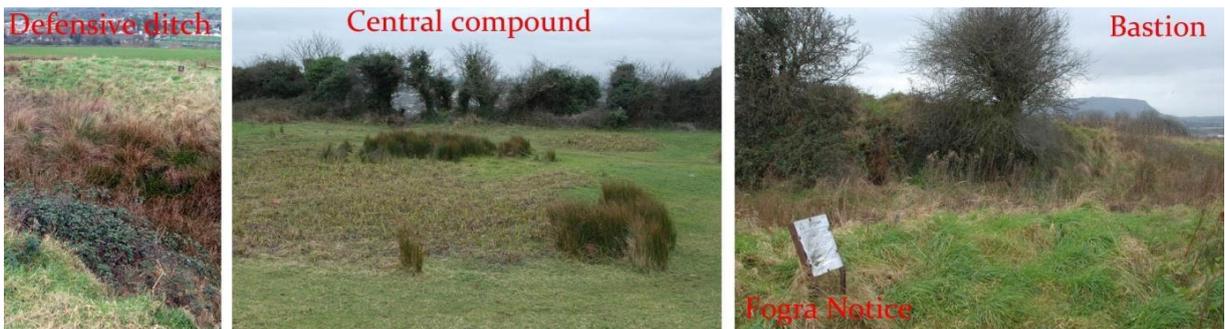
Above: The elements of the Green Fort (raised platform, banks, ditch, bastions) can be difficult to read, and despite the presence of two Fógra notices from the National Monuments Service and the information board placed at the entrance to the park, it may be difficult for the general public to understand the layout and significance of the fort.

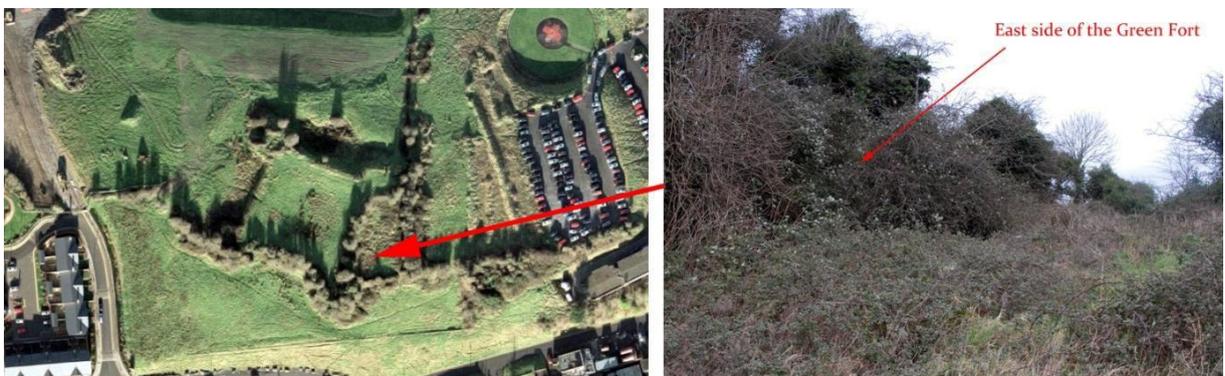
Above: The east side of the fort is partly water-logged and overgrown and is largely inaccessible, and it is not clear that an archaeological monument is present.

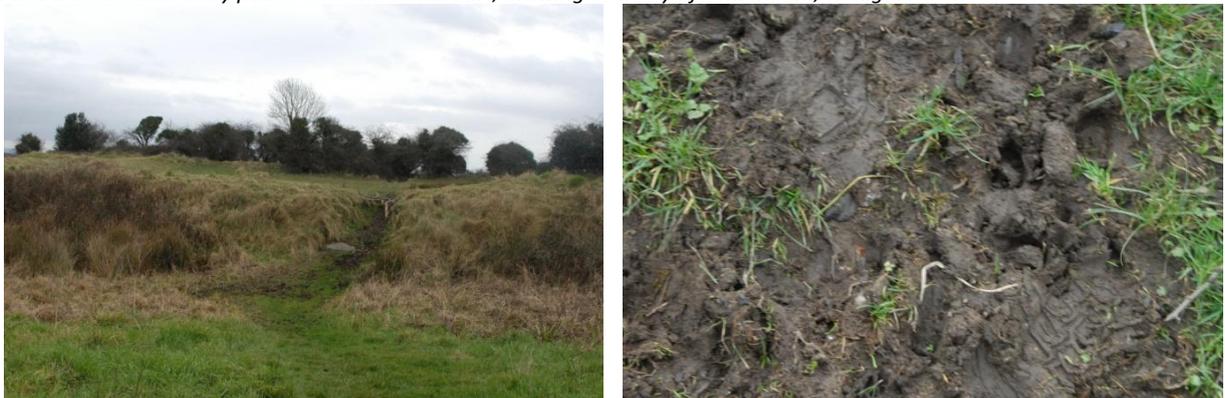
Above: The main access onto the fort shows minor damage from human and animal traffic.

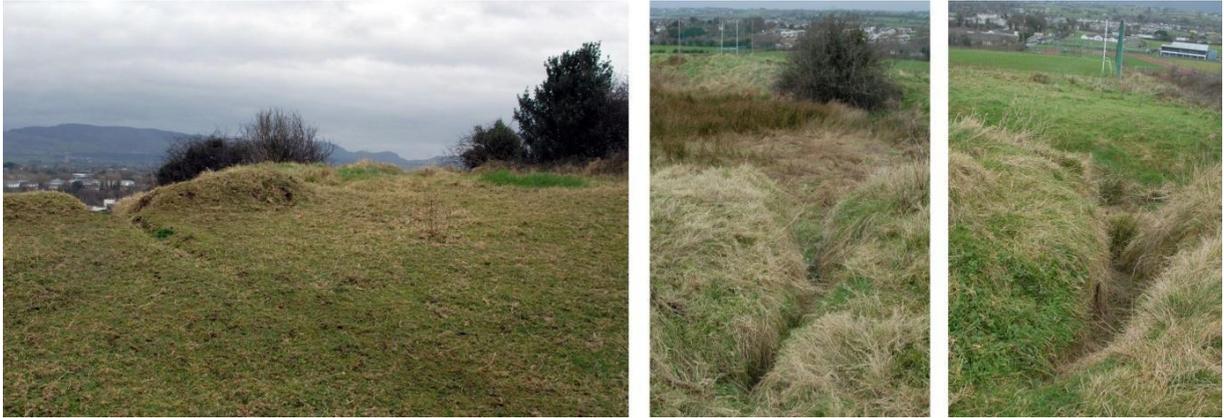
Above: Access routes on the north bank of the fort forming relatively deep cuts into the earthen banks.

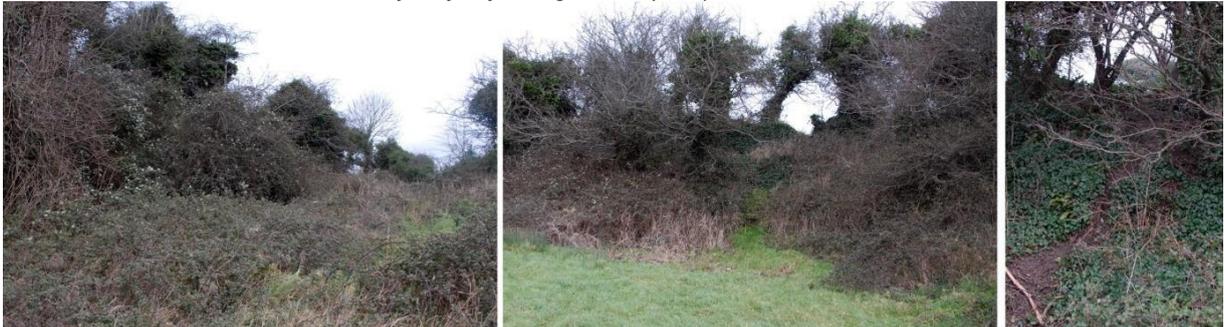
Above: The east side of the fort is largely inaccessible (left). The south bank and bastions are largely overgrown and former access paths are closing up. Access paths on the south slope are indicated by trackways of exposed soil.

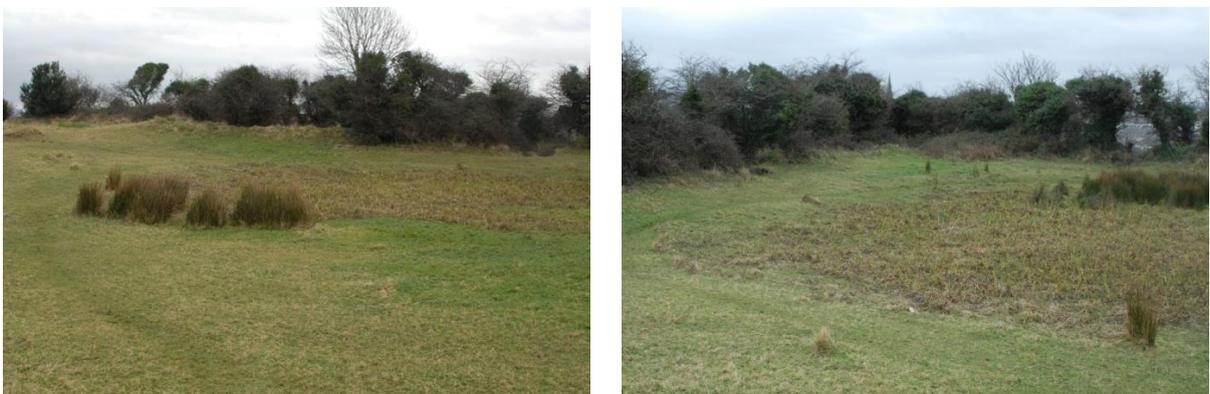
Above: The central section of the fort appears waterlogged at times, and pathways through the fort tend to avoid this area.

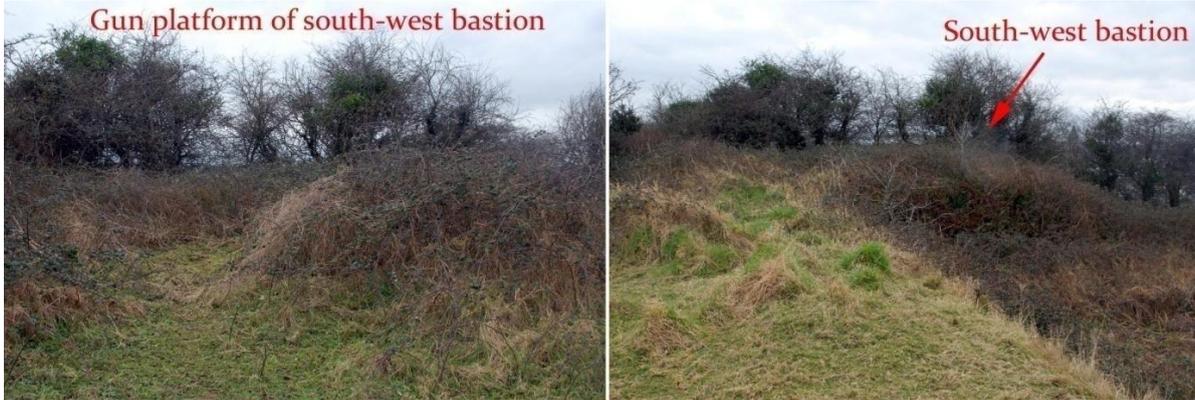
Above: The south-west bastion is obscured by brambles and its extent is unclear.

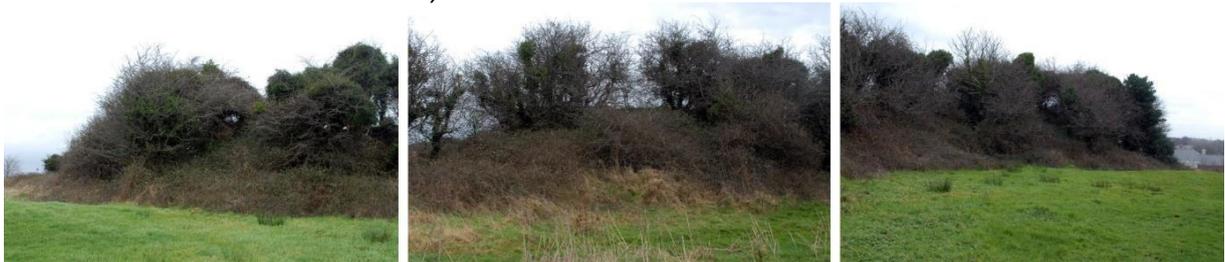
Above: The southern side of the Green Fort features mature vegetation and is arguably the most imposing side of the monument, with views over Sligo town.

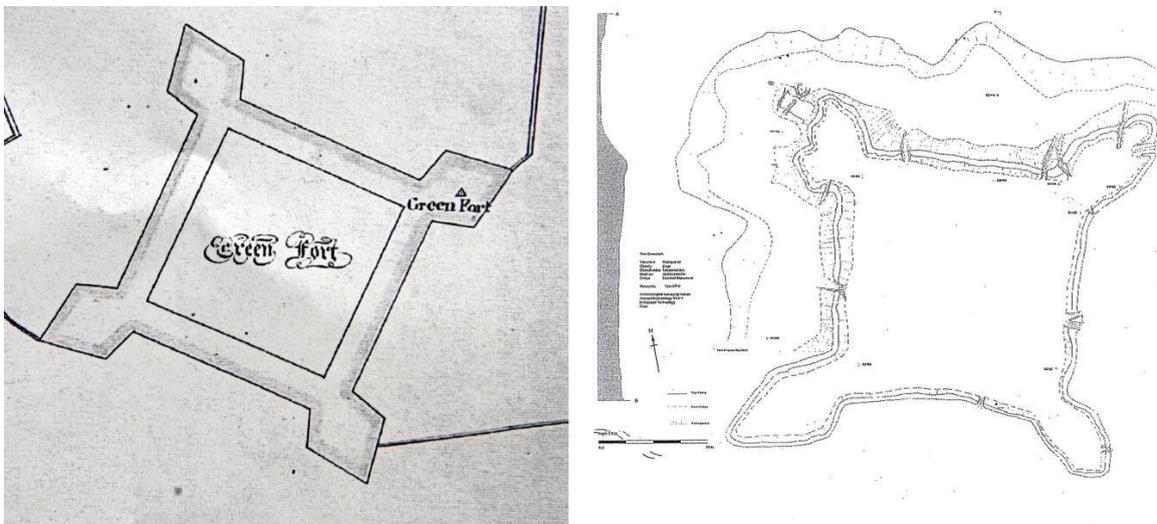
Above: Contrast between the 1837 Ordnance Survey map of the Green Fort (left) and a drawing prepared by Sam Moore, IT Sligo in June 2016 (right) showing recession of all four banks, and loss of detail to all bastions.

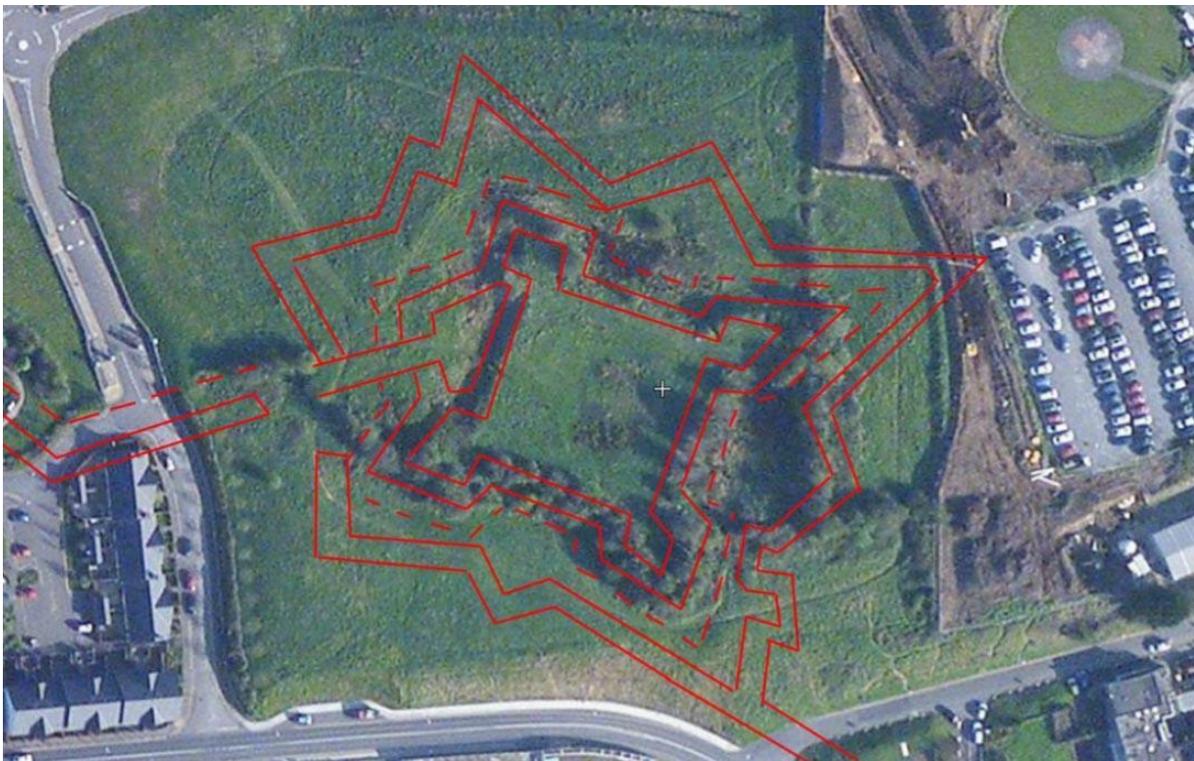
Above: Overlay of Luttrell's plan of the Green Fort and adjacent late seventeenth-century earthwork town defences prepared by Sam Moore, IT Sligo. No trace of these extensive earthen defences are visible at ground level. However, nearby archaeological excavations have confirmed that stretches of these defences survive below ground level.

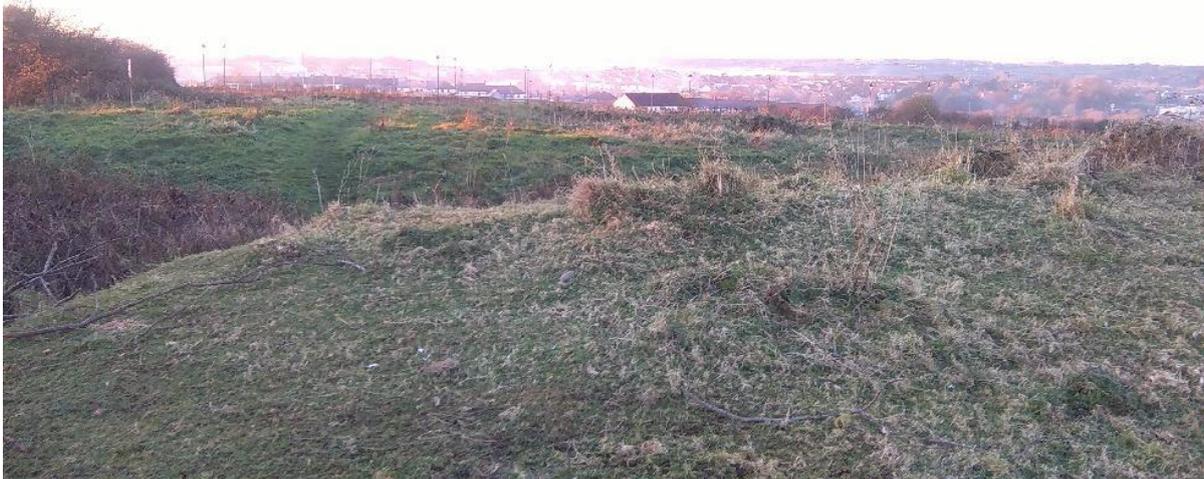
Within the confines of the fort itself grassland is currently grazed by horses and the sward is cropped short in places. On the steep-sided embankments, where horses cannot graze regularly, the sward is longer. Among the species noted on unimproved pasture on the site were creeping bent (*Agrostis stolonifera*), self heal (*Prunella vulgaris*), creeping buttercup (*Ranunculus acris*), meadow buttercup (*Ranunculus acris*), cats ear (*Hypochaeris radicata*), dandelion (*Taraxacum officinale* agg.), ragwort (*Senecio jacobaea*), clover (*Trifolium* spp.), spear thistle (*Cirsium vulgare*), sorrel (*Rumex acetosa*), crested dogs tail (*Cynosurus cristatus*), yarrow (*Achillea millefolium*) and sweet vernal grass (*Anthoxanthum odoratum*).

Figure 1: Unimproved grassland at the Green Fort in the foreground. This close-cropped sward is currently maintained by grazers. Rough grassland can be seen in the middle distance. November 24th 2016.

If grazing ceases then a mowing regime should be devised within the boundaries of the fort itself. At present, the grazing regime is too intensive to allow flowering of the diverse range of grassland species. Therefore, it is recommended that pasture on the site should not be mowed until after the orchid flowering season (approx. mid-July), with the exception of any grassed pathways. A light mowing regime (every 3 weeks approximately) with the mower set to a high sward setting (with the exception of grassed pathways) should then be used for the remainder of the season. Clippings should be removed and composted off-site or on another part of the site.

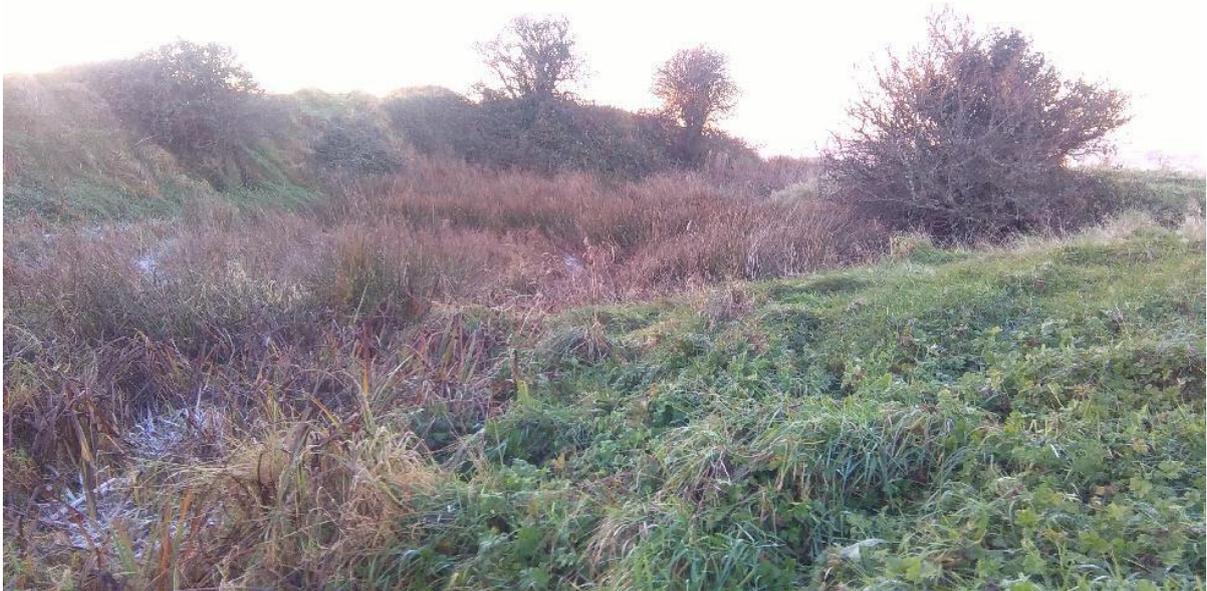
In depressions immediately surrounding the fort and also in circular patches within the fort itself there are areas of wet grassland with elements of marsh vegetation. The species most clearly visible during the winter is flag iris (*Iris pseudacorus*), although other water-tolerant species are also present including hairy willowherb (*Epilobium hirsutum*) and various rushes soft rush (*Juncus effusus*), hard rush (*Juncus inflexus*) and jointed rush (*Juncus articulatus*). Hairy willowherb (*Epilobium hirsutum*) was also present. Hairy sedge (*Carex hirta*) was found in one location where marsh-type vegetation graded into bramble scrub.

Figure 2: Marsh/wet grassland in the north-facing ditch at the Green Fort. Rushes, flag iris and grasses are the main plants visible in winter. November 24th 2016.
