THE GREEN FORT CONSERVATION PLAN

Draft 7.0 Document for Public Consultation
September 2017

Prepared by Jason Bolton, Pat Dargan and Niamh Roche for Sligo County Council

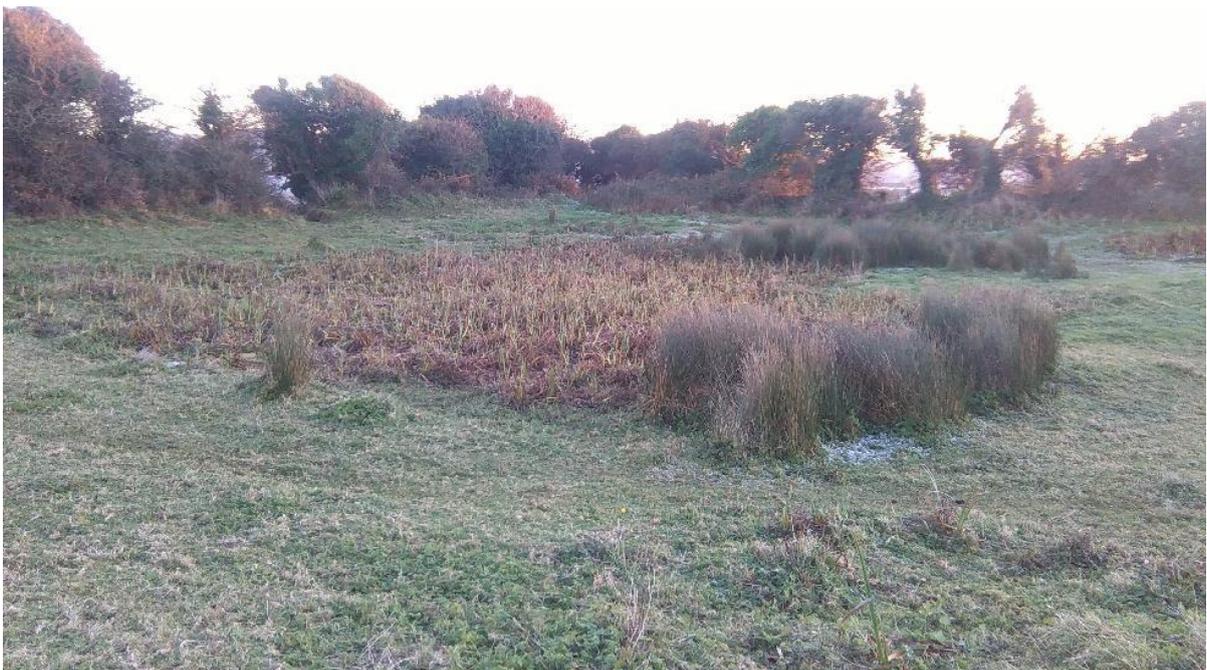
Figure 3: Marsh/wet grassland on the Green Fort itself. November 24th 2016.

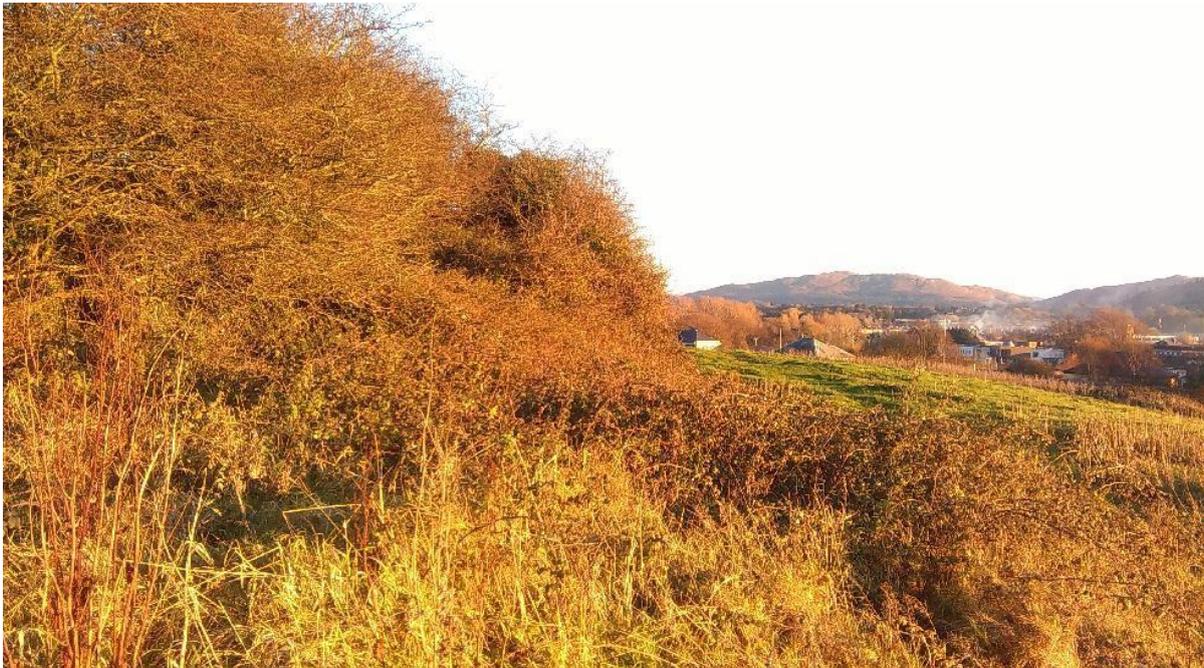
Figure 4 Scrub dominated by brambles spreading from the south facing hedgerow at the Green Fort. November 24th 2016.

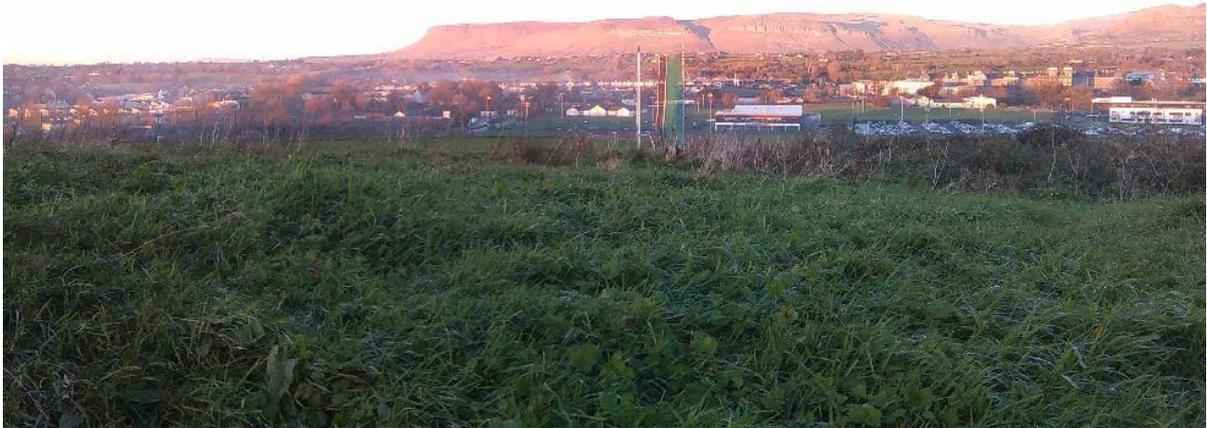
This grassland has not been maintained by grazing. As a result of the lack of cutting or trampling a matt of decomposing vegetation has formed under the sward in places and in others it grades into scrub. Species that are found here include rough grasses such as false oat, cock's foot, Yorkshire fog (*Holcus lanatus*), smooth meadowgrass (*Poa pratensis*) as well as herbaceous plants including, field thistle (*Cirsium arvense*), ragwort, bush vetch (*Vicia sepium*), broad dock (*Rumex obtusifolius*), silverweed (*Potentilla anserina*), knapweed (*Centaurea nigra*), sharp flowered rush (*Juncus acutiflorus*) and nettles (*Urtica dioica*).

Figure 5: Rough grassland with various grass species and creeping buttercup. Facing north towards Ben Bulben and the Dartry Mountains at the Green Fort. November 24th 2016.

Most of the areas immediately surrounding the Green Fort constitute rough grassland. An annual mowing regime is recommended. While some plants found in rough grassland, such as nettles, docks and thistles may be considered unsightly by some, they are hugely beneficial for many invertebrates including butterflies and pollinators. Therefore, it is not recommended that they should be controlled by herbicidal sprays or mechanical means other than as part of an annual mowing regime.

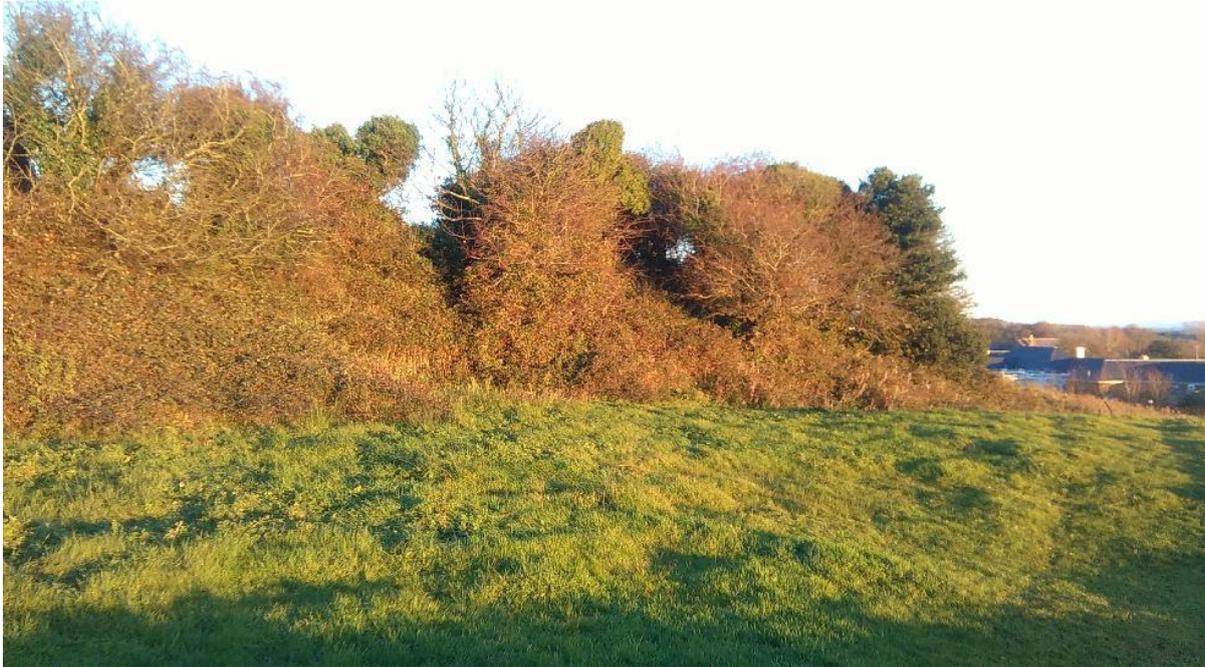
Hedgerows on the site provide shelter and food sources for songbirds and mammals. Taller woody species found along the hedgerows include hawthorn (*Crataegus monogyna*), ash (*Fraxinus excelsior*), elder (*Sambucus nigra*), alder (*Alnus glutinosa*), holly (*Ilex aquifolium*), willow (*Salix* sp.), and blackthorn (*Prunus spinosa*). Herbaceous ground flora species include broad buckler fern (*Dryopteris dilatata*), scaly male fern (*Dryopteris affinis*), male fern (*Dryopteris filix-mas*), soft shield fern (*Polystichum setiferum*), harts tongue fern (*Phyllitis scolopendrium*), germander speedwell (*Veronica chamaedrys*), lesser celandine (*Ranunculus ficaria*), lesser hogweed (*Heraclium sphondylium*), tutsan (*Hypericum androsaemum*) and lords and ladies (*Arum maculatum*).

Figure 6: Hedgerow with hawthorn, ash and ivy as well as bramble scrub at its base, the Green Fort. November 24th 2016.

It is recommended that hedgerows are left as they are, where they are not causing damage to the monument. Little management is required since they do not need to be stockproof. Any hedgerow management, such as trimming should not be carried out during the bird nesting season March 1st to August 31st.

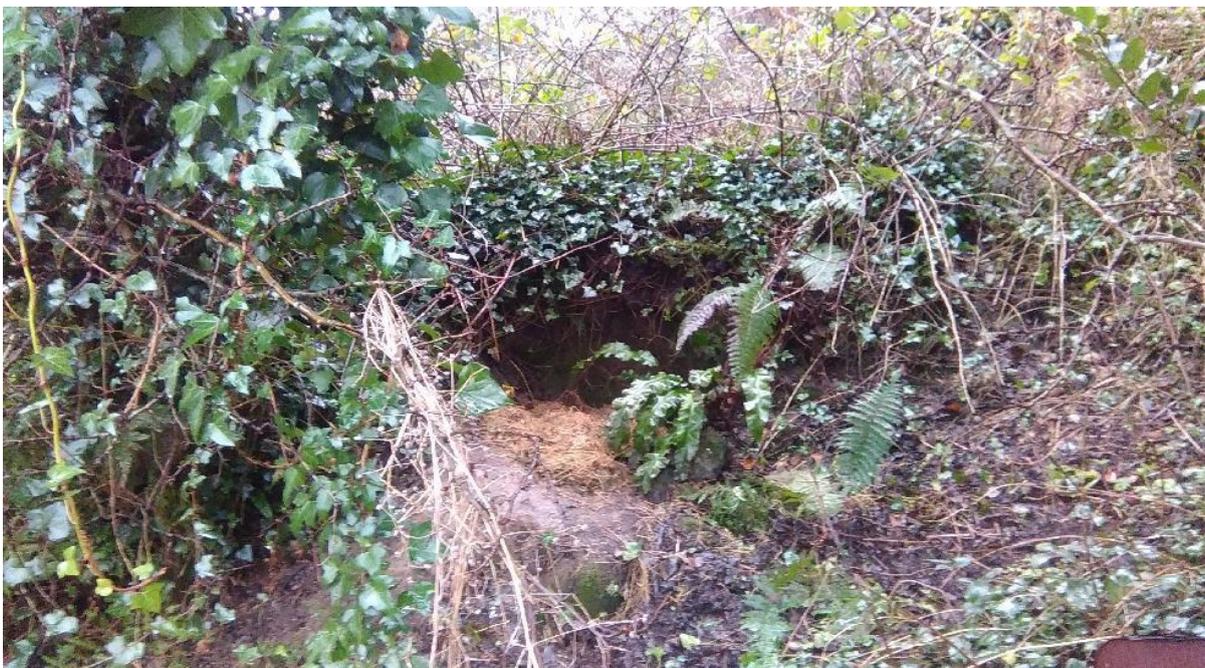
Figure 7: Active badger sett at the Green Fort January 7th 2017. Fresh bedding was deposited at the entrance.
