N4 Collooney to Castlebaldwin, *Proposed Road Development*

APPENDIX NO. 14.1

Hydrological study of Tawnagh Lake, Tawnagh, County Sligo

PREPARED BY: Minerex Environmental Limited

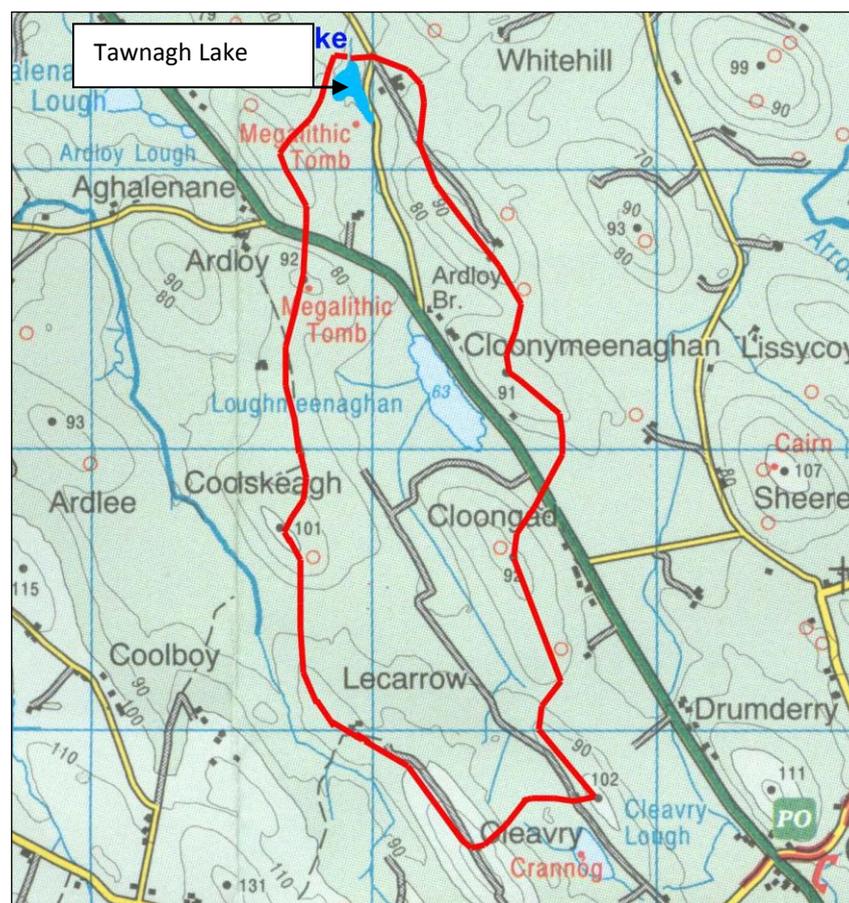
The surface catchment area of Tawnagh Lake is approximately 1.9 km². This area extends to the topographic highs around the lake and approximately 2km to the south, including the catchment of Loughymeenaghan. Discharge from the lake was recorded as approximately 15 l/s during the site visit, equating to 7.8 l/s/km², which is relatively low. This could be due to the fact that it had not rained heavily in the time running up to or during the site visit, or it could possibly indicate that the surface drainage system in the catchment is losing water to the groundwater system. It does not indicate that groundwater discharge from outside the surface catchment is discharging into Tawnagh Lake and there is no reason to assume that the lake has a larger catchment area than the known area of contribution as defined topographically.

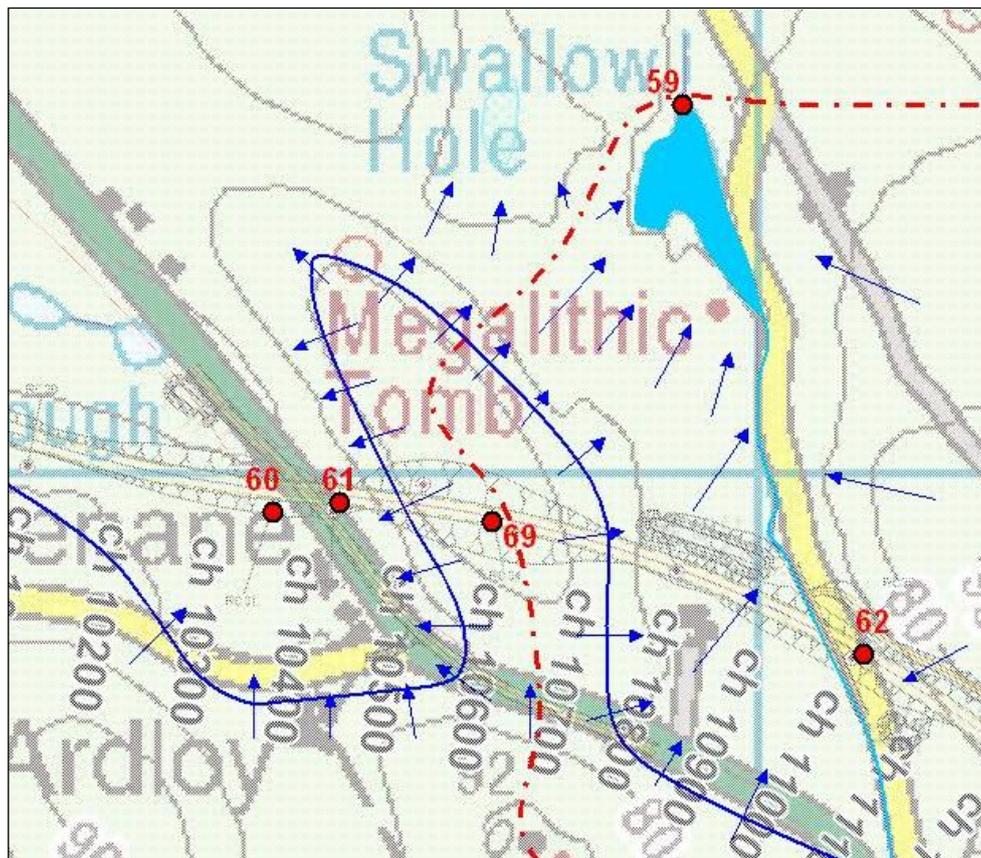
The map below shows recorded groundwater levels in site investigation boreholes. The likely current position of the 67maOD groundwater contour was extrapolated from these (the level of the base of the cut). The groundwater flow arrows show the likely groundwater flow routes (although in reality these will be different to some degree due to bedrock structural control of local groundwater flow direction in karst aquifers). The broken red line shows the likely current position of the groundwater catchment boundary for Tawnagh Lake.

Map showing the existing groundwater catchment (red line) of Tawnagh Lake with borehole locations (red dots), groundwater levels (red numbers), the 67maOD groundwater contour (blue line), groundwater flow direction (blue arrows).

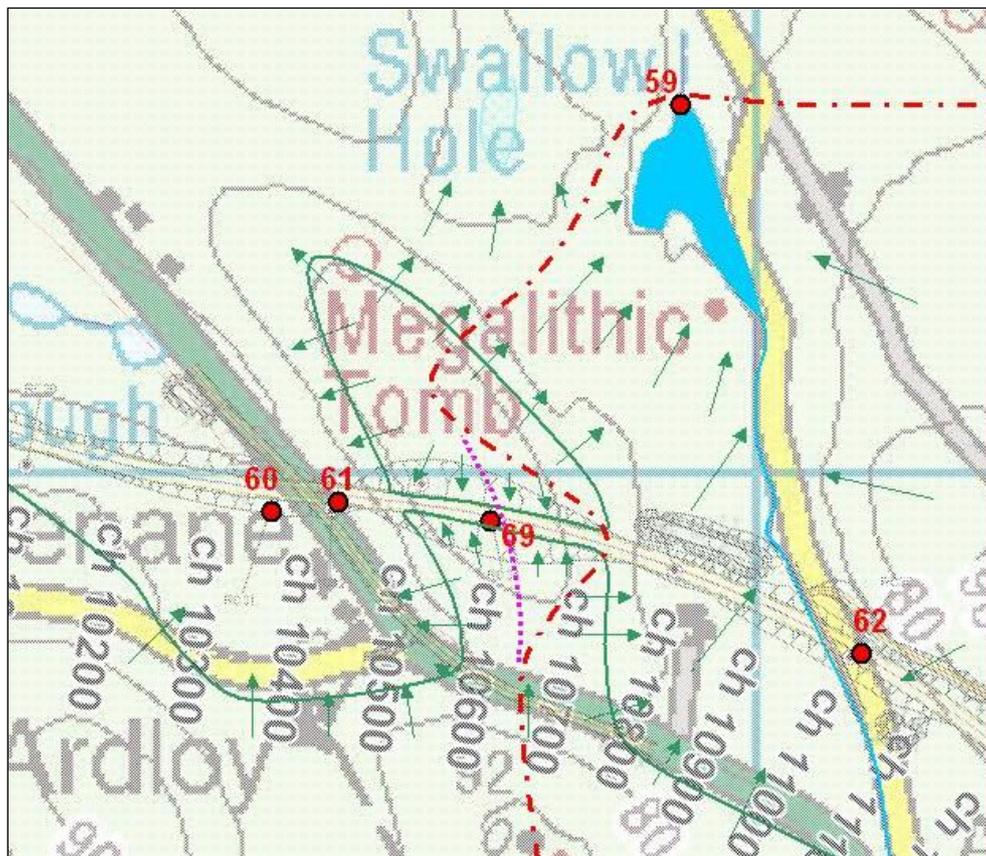
Map showing the likely groundwater conditions post-construction with groundwater catchment (red line) of Tawnagh Lake with borehole locations (red dots), groundwater levels (red numbers), the 67maOD groundwater contour (green line), groundwater flow direction (green arrows).
