Appendix I

Strategic Flood Risk Assessment

Using the available information, this report outlines the flood potential of the lands that were zoned in the Ballymote LAP 2005-2011 and in the current plan 2012-2018.

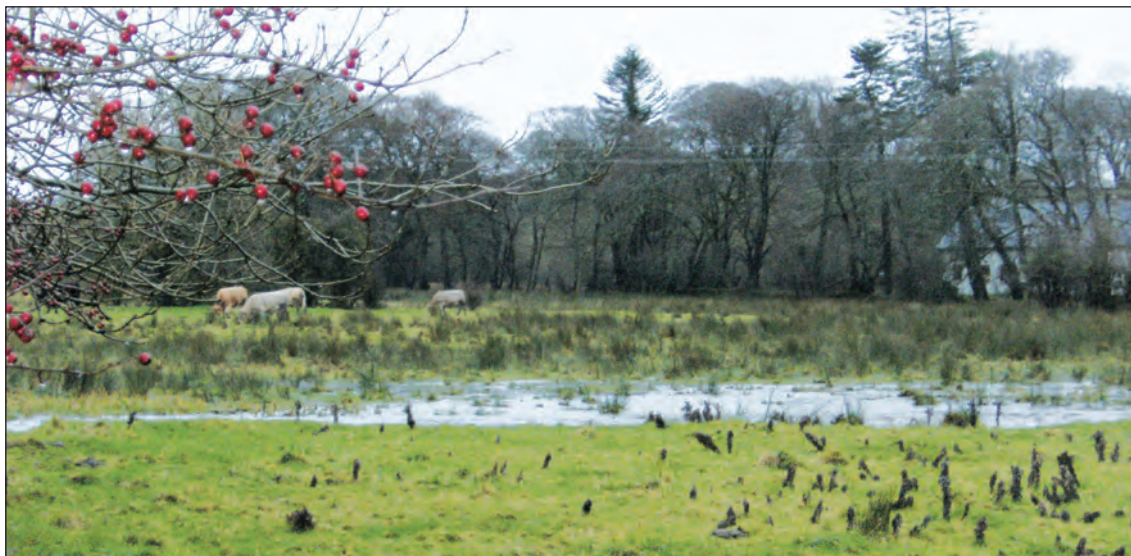
In November 2011, the Area Engineer took a series of photographs of the lands to the south-west of Ballymote after a period of prolonged rainfall. The photographs clearly show that the lands are vulnerable to flooding during periods of heavy rainfall. Below - photo taken in November 2011

In relation to Ballymote River, there are recurring flood events on undeveloped lands on the south-western periphery of the town. The culvert in that area is not capable of taking the flow during periods of prolonged heavy rainfall and this leads to the flooding of the lands adjoining the river.

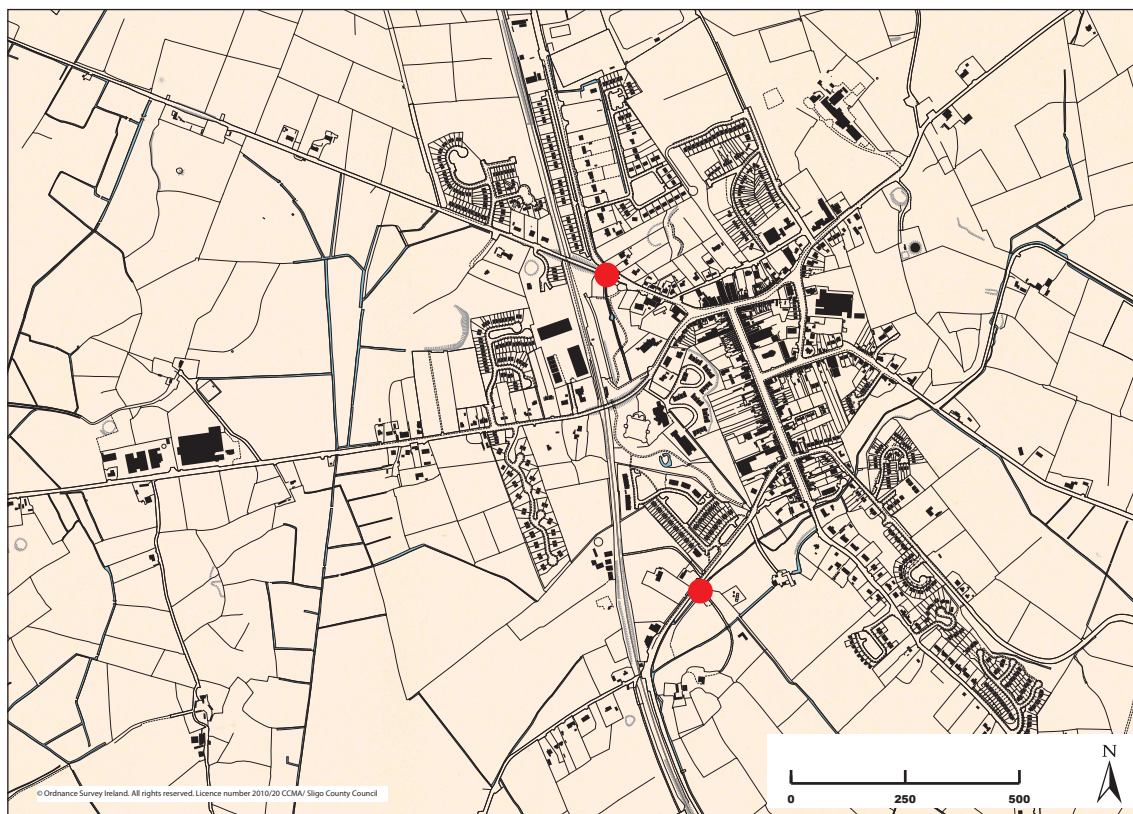
Using the information that is available about flooding in Ballymote, it is possible to ascertain the risk of flood within the town. Where flooding does occur, the principle of the sequential approach will be applied. The general location of the lands mentioned in the following subsections is marked on the map below.

This refers to lands that are currently developed and are zoned for residential and industrial uses. A significant portion of the lands is designated as benefiting lands by the OPW. There is a small drain to the north-west of the town, running along the R293. The adjacent lands have been developed. During periods of prolonged heavy rainfall, the drain floods and, in case of an extreme event, properties on the left bank could be flooded. Downstream there are a number of raised walls along the front of properties on the left bank of the watercourse; these walls may divert water onto the R293.

This refers to 2.19 ha of land that were zoned residential in the Ballymote Local Area Plan and are designated as “benefiting lands” by the OPW.

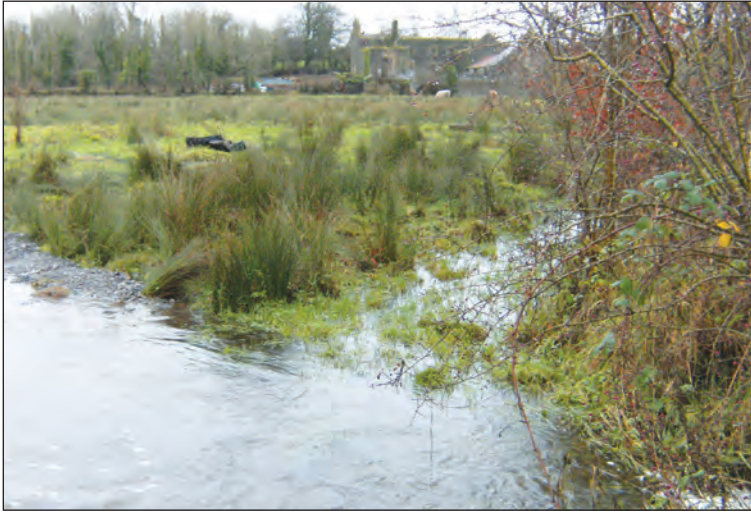
6.2 Lands to the south-west of the town, adjacent to the Ballymote River

The Ballymote River runs along the northern section of the subject lands.

There are recurring flood events at this location, as the culvert is not capable of accommodating the flow of water during periods of prolonged heavy rainfall.

This leads to the flooding of the lands adjacent to the river.

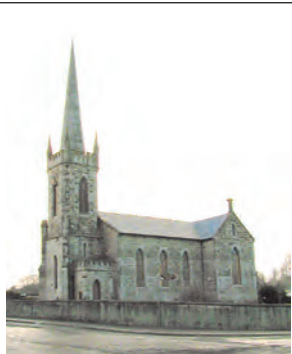
RPS No. 43 – Emlaghfad Parish Church

This is a free standing, gothic revival limestone church, c.1800. The Emlaghfad Church of Ireland is a fine early 19th Century building strategically located in the heart of Ballymote with its own grounds. In addition to its architectural detailing it is also recognised that the church has significant historical importance.

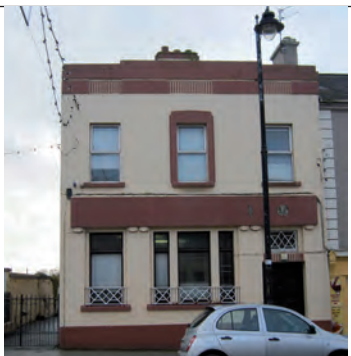
RPS No. 44 – Former Garda Station

This is a three-bay, two-storey rendered former bank, built in c. 1930 and formerly used as a Garda Station. Features include a hipped slate roof set behind parapet, clay ridge tiles and a smooth-rendered corbelled chimneystack. This highly individualistic building combines Art Deco elements in an eclectic and uninhibited fashion. It contributes significantly to the character of streetscape.

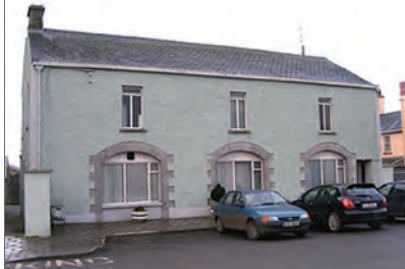
RPS No. 45 – Former Market House

A detached three-bay, two-storey rendered former market house, built in c. 1870 and now used as a dwelling house. Features include a pitched artificial slate roof (c. 1980), ashlar limestone corbelled chimney-stack, ground-floor arches (infilled) and substantial gate piers. Despite renovations, it remains a building of distinction and one which makes a positive contribution to the streetscape.

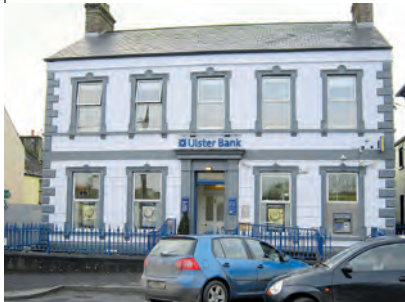
RPS No. 46 – Ulster Bank

A detached five-bay, two-storey rendered bank premises, built c. 1890. Features include a pitched slate roof, clay ridge tiles, corbelled chimneystacks, square-headed window and door openings and wrought-iron railings with embellishments. The building is an excellent example of the consummate skill and confidence with which commercial premises were designed in Victorian and Edwardian times. There is an abundance of rendered detail.

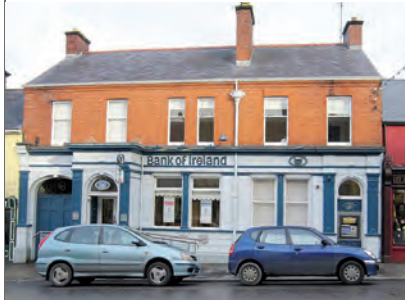
RPS No. 47 – Bank of Ireland

An attached six-bay, two-storey rendered building from c. 1925 – formerly Hibernian Bank. Features include a pitched slate roof, red brick corbelled chimneystacks, flat-roofed porch, red brick walling at first floor, round-headed entrance door with fanlight and an elliptical carriage arch. This building departs from local traditions in its use of red brick and classical motifs. The wrought-iron grille to the carriage arch is significant for its artistic flourish and old HB logo.

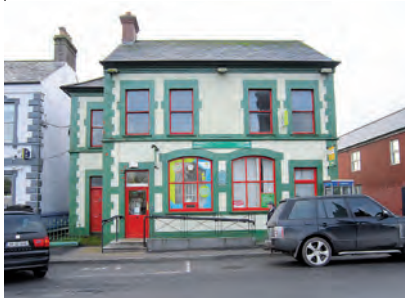
RPS No. 48 – Ballymote Post Office

A detached, four-bay, two-storey rendered commercial premises, built c. 1890. Features include a pitched slate roof, red brick corbelled chimneystacks, elliptical and square headed windows and metal railings. This robust building utilises quality brick detailing to enhance its plain facade. It forms part of a group of distinctive buildings on the street.

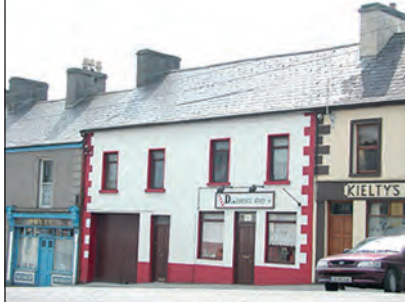
RPS No. 49 – House/Shop (D's Barber Shop)

This is a terraced, four-bay, two-storey rendered former house, built c. 1880 and now used as a barber's shop. Features include an integral carriage arch, pitched slate roof and rendered corbelled chimneystacks. This building makes a colourful contribution to the streetscape and is in-keeping with the rest of the terrace.

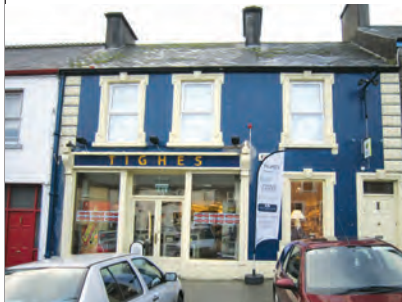
RPS No. 51 – House/Shop (Tighe's, formerly Cawley's)

A terraced, three-bay, two-storey rendered house, built in c. 1870. Features include a pitched slate roof, rendered corbelled chimneystacks, cast-iron gutters, painted timber shop front and a deeply recessed doorway. This well-proportioned building fits comfortably in the streetscape. It boasts a fine and well-preserved shop front and well-executed moulded detail around doors and windows.

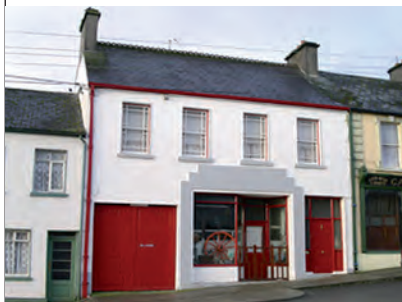
RPS No. 52 – House with shopfront

A terraced, four-bay, two-storey rendered former house, now in use as a shop, built in c. 1870. Features include an integral carriage arch, a recessed shop doorway with stepped surround, a pitched slate roof, rendered corbelled chimneystacks and a timber gate entrance. The later addition of an unusual shop front adds diversity to the streetscape and echoes art deco style of the old Garda Station.

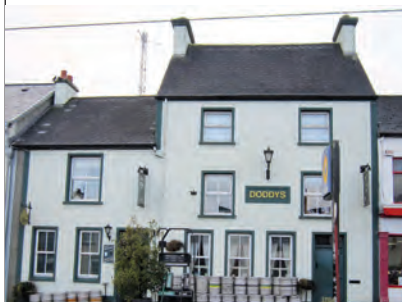
RPS No. 53 – House/Shop (Doddy's)

A terraced, two-bay, three-storey public house built in c. 1870. Features include a pitched artificial slate roof, rendered corbelled chimneystacks with clay pots and square-headed door and window openings with raised surrounds. This brightly-painted public house dominates the streetscape with its high roofline and busy facade. The roadside petrol pumps are a rapidly disappearing feature of Irish towns.

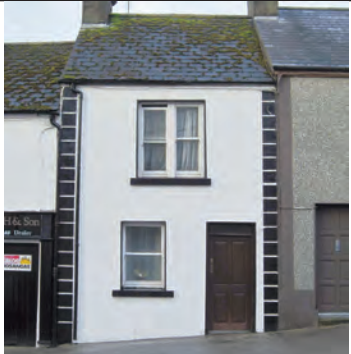
RPS No. 54 – House

A terraced, two-bay, two-storey rendered house built in c. 1860. Features include a pitched artificial slate roof, rendered corbelled chimneystack and square-headed windows and door. This modest house makes a significant positive contribution to the streetscape, being one of the few to retain sash windows and straight quoins. It is a rapidly disappearing type of building in Irish towns.

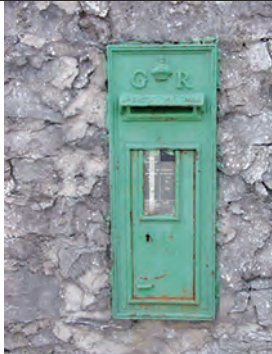
RPS No. 55 – Wall-mounted post box

A cast-iron post box installed in c. 1915. It has a vertical, oblong shape with a moulded edge and protruding flap with the embossed GR and crown insignia. This is of significant historic and social interest.

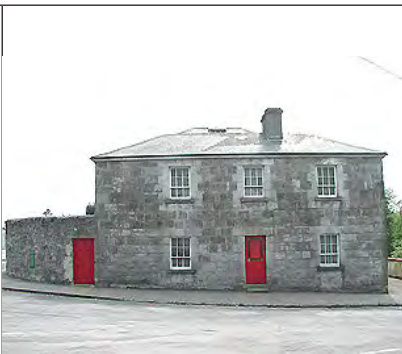
RPS No. 56 – Stone House

This is a detached three-bay, two-storey stone house built in c. 1830. Features include a hipped slate roof, rock-faced coursed ashlar walling, square headed window and door openings with tooled dressing, front steps and a curved rubble stone boundary to the east. This handsome, slightly asymmetric house is enhanced by the retention of the original sash windows and entrance door. It is one of only a few ashlar stone buildings in the village and therefore adds variety and texture to the streetscape.

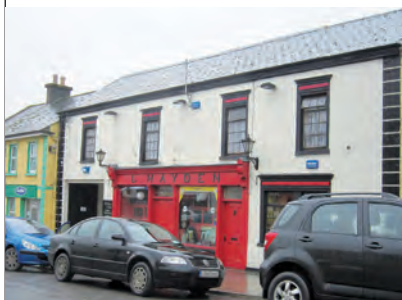
RPS No. 57 – L. Hayden’s pub and town house

This attractive premises (1830 – 1870) situated in the heart of Ballymote derives much of its charm through the early shopfront to the bar. The shopfront retains much of its original features including its carved timber corbels and its double flat paneled timber door. Other features of note include the decorative frieze over the first floor windows and the natural slate roof.

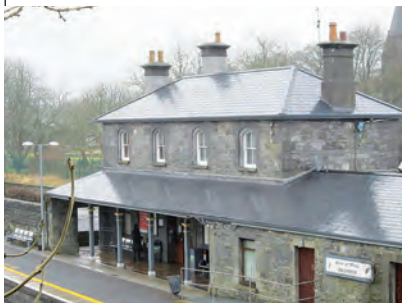
RPS No. 59 – Ballymote Railway Station

This railway station (1860 – 1862) is in very good condition externally and is a better example of a typical nineteenth century railway station, with fine detailing and many original features still remaining. The station is set in a low-lying site at the very historic southern end of Ballymote located between the Castle, Roman Catholic Church and graveyard.

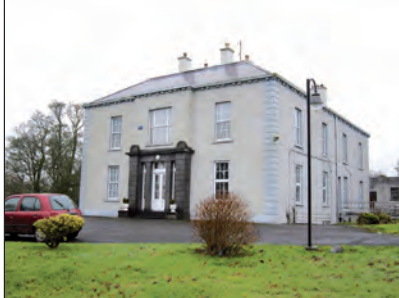
RPS No. 104 – Earlsfield House (Sisters of Mercy Convent)

Earlsfield House (1750 – 1760) is a very attractive Georgian House, now used as a convent. The building is of architectural significance due to its pleasing design and retention of many features, including its limestone door case and timber sash windows. It is also of historic significance due to its association with the Gore Booth family.

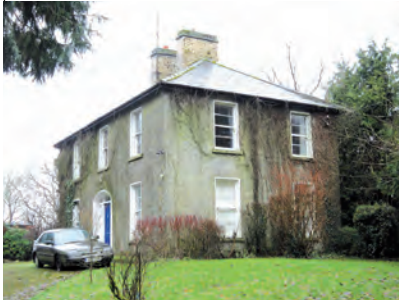
RPS No. 117 – Castlevue House

A detached, three-bay, two-storey rendered house built in c. 1890. Features include a hipped slate roof, yellow-brick corbelled chimneystacks, chamfered plinth, segmental-headed doorway with fanlight, moulded surrounds, wrought-iron gates, stone piers and a two-storey hipped roof outbuilding. This fine house retains many of its original features. It relates well to its contemporary outbuilding and is well sited.

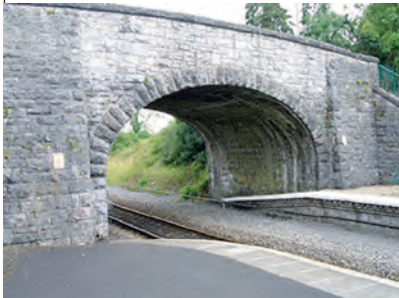
RPS No. 118 – Road-over-railway bridge

A single-span bridge built c. 1875. It runs on a north-south axis with flanking steps to either side of the track. The walling is made of squared-and-snecked rubble limestone. The arch is elliptical with rock-faced limestone ashlar voussoirs. The bridge is substantially unaltered and is a pleasing symmetrical composition utilising natural stone, which relates well to the contemporaneous railway station.

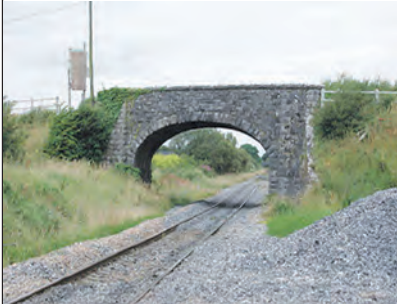
RPS No. 119 – Road-over-railway bridge

A single span bridge built c. 1875. The walling is made of squared-and-snecked rubble limestone. The arch is elliptical and is rock-faced with ashlar limestone voussoirs. It spans in splay south-east to south-west. This fine bridge is unusual for its splayed spanning. The good quality stonework is a notable feature.
