# **N4 Collooney to Castlebaldwin, Proposed Road Development**

## **APPENDIX NO. 12.3**

### **NON-VOLANT MAMMAL REPORT**

**ECOFACT Environmental Consultants Ltd.;**

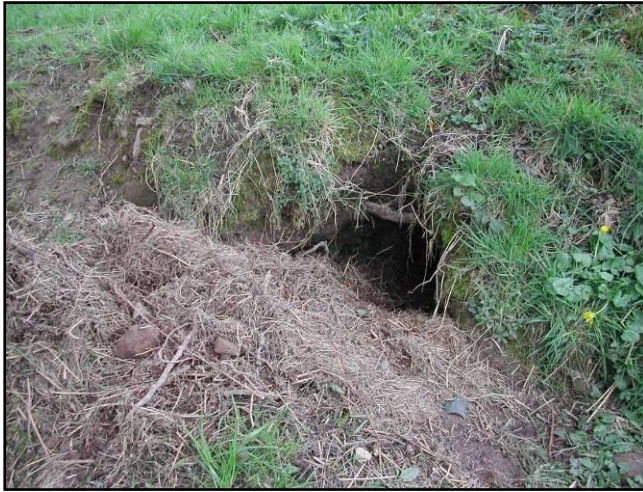
**Plate 1** Representative photo of an active badger sett with bedding at the entrance. Taken from the study area during the 2006 survey.

In the spoil heaps of active badger setts vegetable matter such as grass, bracken, moss or leaves may be found because badgers use vast quantities of bedding, which is periodically replaced and this will contain badger hairs (see below). This distinguishes an active badger sett from a fox's earth, because foxes do not use bedding. Bones may be found in the spoil heaps of both active badger setts and fox earths. In May if the spoil heap outside a well used entrance is flattened and hardened it is a sign that cubs are present and have been at play.

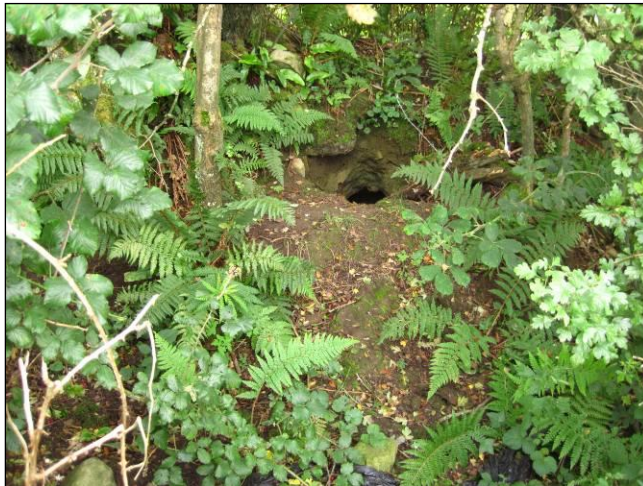
**Plate 2** Active sett north of Cloonlurg (2010).

In the Cloonlurg area, the proposed road alignment crosses a minor tertiary road and passes through a large area of coniferous plantation. A single entrance sett was recorded to the north of this minor road, close to the location of a previously recorded main sett which is no longer present. Two active setts, one a main sett and one an active annexe site, were recorded from the coniferous woodland directly south of the proposed road corridor (approximately 80m). Although this area is fairly wet, extensive badger foraging was recorded within the line of the proposed road route during the 2012 survey; this confirms previous records of badger activity from this area from the 2006 survey. No change was recorded during the 2013 survey.

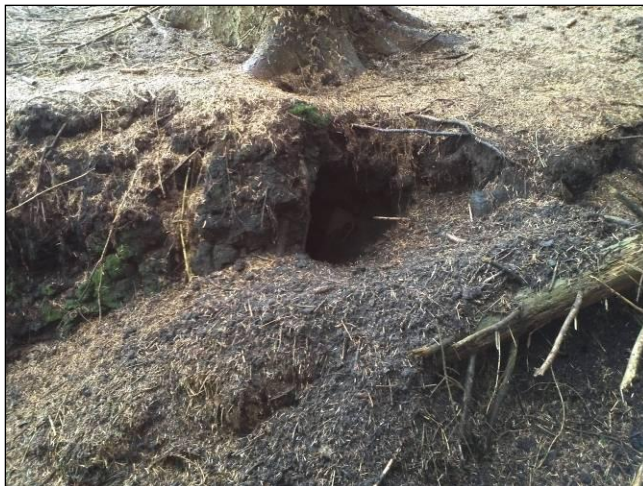
**Plate 3** One entrance of the nine entrance main sett recorded in a peat bank in the conifer plantation at Cloonlurg (2012).

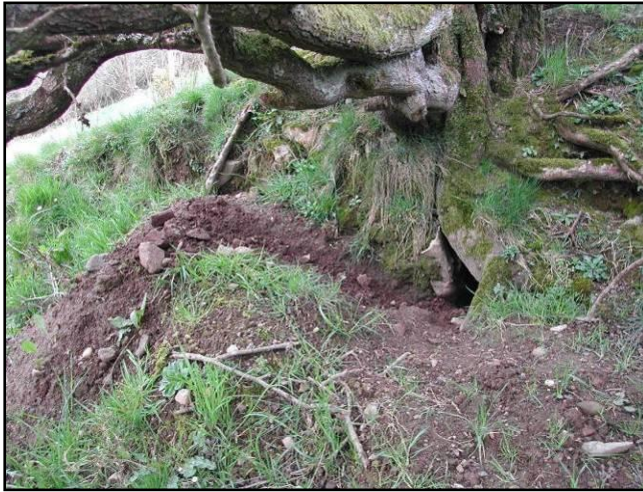
**Plate 4** Badger sett at Tawnagh recorded as active between 2006 and 2012.

Two active setts were recorded from the west facing elevated ground to the north of Ardloy Bridge in the townland of Tawnagh. These sets were both identified in the 2006 survey, one of which was identified as being inactive during 2010. Both setts are located directly east and close to the existing minor road which is crossed by the proposed road alignment from Ardloy. The southernmost, single entrance dwelling lies within the line of the road. A single entrance annexe sett associated with this badger community was identified to the southeast and was active during 2006. This dwelling is in the line of the proposed road corridor and was found to be inactive in 2010 and was no longer present in 2013.

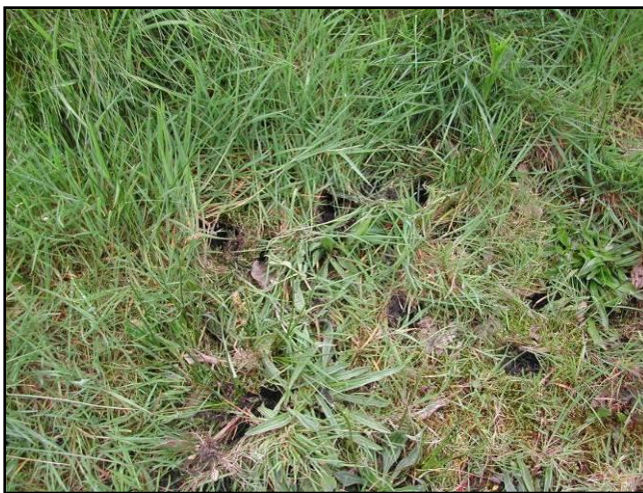
**Plate 5** 'Snuffle holes' – a sign of recent badger feeding activity.

One of the most distinctive badger feeding signs are snuffle holes, small pits drilled typically in areas of short grass, in pursuit of retreating earthworms.

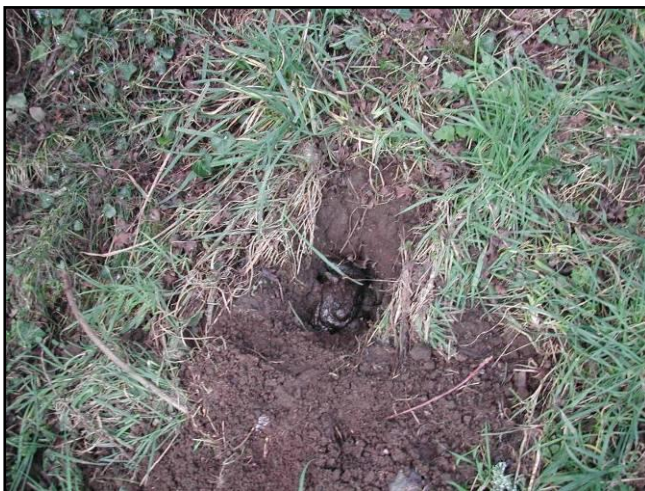
**Plate 6** A badger latrine.

Appearance: Dung pits are funnel shaped depressions about 15 cm deep, with a diameter at the top of about the same measurement, into which badgers defecate. Often dung pits will be grouped together to form a latrine. When a pit becomes full it is left uncovered and another dug nearby.

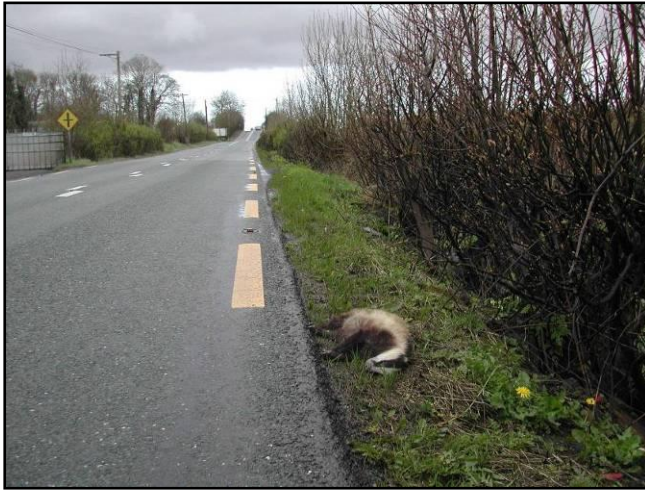
**Plate 7** Badger road mortality along the existing N4 to the north of the Carrownagark cross-roads. This was the only badger road mortality recorded during the current survey.

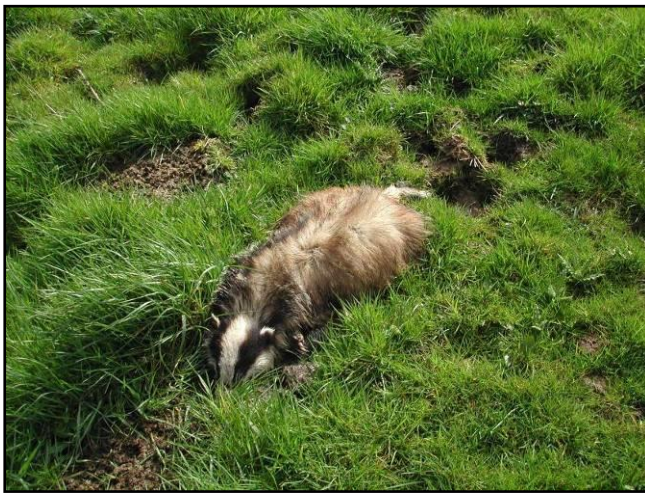
**Plate 8** Dead badger (apparently shot) near the proposed N4 corridor at Carrownagark (2006).
